## General Information

| Make | Toyota | Model | Vios |
| Registration No. | DBJ6249 | Chassis No. | PA1B18F32P4221189 |

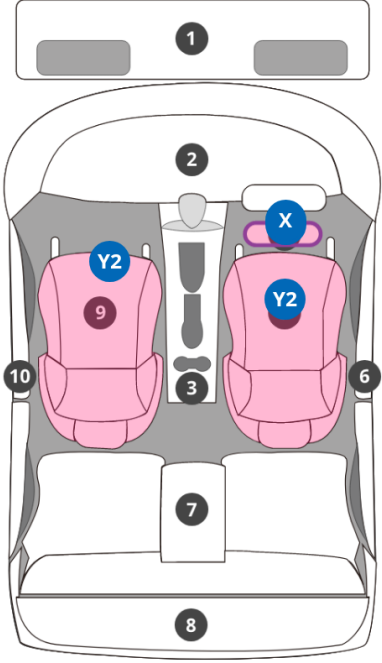
| Interior Evaluation : <b>B</b> | Exterior Evaluation : <b>C</b> |
|---|---|
| <b>Remarks</b><br>(R) Front Floor Mat - Missing - Yes / Mat Other - Missing - Yes / (L) Front Seat - Grime - Small / (R) Front Seat - Grime - Small | <b>Remarks</b><br>Rear Bumper, Lamps, Panels - Scratch - Small / (L) Front Door, Molding - Scratch - Small / (R) Front Fender, Molding - Scratch - Medium / (R) Front Door, Molding - Scratch - Large / (R) Rear Fender, Molding - Dent - Small / (L) Rear Fender, Molding - Scratch - Minimal / (L) Rear Door, Molding - Scratch - Medium / (R) Mirror - Scratch - Minimal / Trunk Hood, Rear Gate - Scratch - Minimal |
