## General Information

| Make | Hyundai | Model | Stargazer |
| YOM | 2023 | Odo Meter Reading | 10,566 |
| Registration No. | GBA6045 | Chassis No. | MF3NC81DEPJ028142 |

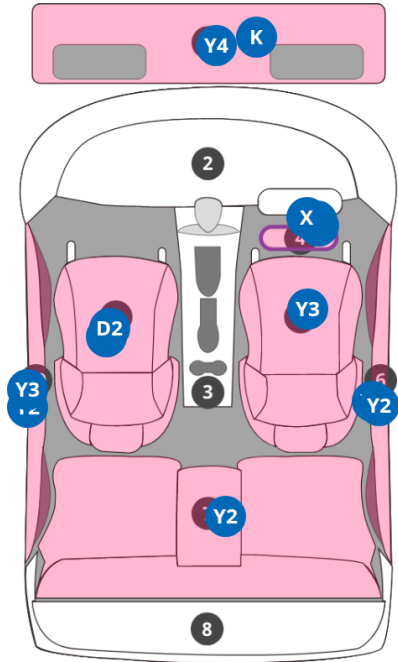
| Interior Evaluation : <span style="color: red;">C</span> | Exterior Evaluation : <span style="color: red;">E</span> |
| <b>Remarks</b><br>(R) Front Floor Mat - Missing - Yes / (L) Front Floor Mat - Missing - Yes / Mat Other - Missing - Yes / Overall Interior - Animal Hair - Yes / Ceiling - Grime - Large / (R) Front Seat - Grime - Medium / (R) Front Trim - Grime - Medium / (R) Rear Trim - Grime - Small / Rear Seat - Grime - Small / (L) Rear Trim - Grime - Small / (L) Front Trim - Grime - Medium / (L) Front Seat - Grime - Small / (L) Front Seat belt - Loose, Deformed - Small | <b>Remarks</b><br>(L) Front Fender, Molding - Scratch - Small / Front Bumper, Grille, Lamps - Scratch - Medium / Bonnet, Headlight - Scratch - Small / (R) Front Door, Molding - Scratch - Medium / (R) Rear Door, Molding - Scratch - Small / (R) Step, In-panel, Side Spoiler - Scratch - Large / (R) Rear Fender, Molding - Scratch - Small / Rear Bumper, Lamps, Panels - Scratch - Medium / Trunk Hood, Rear Gate - Scratch - Medium / (L) Rear Fender, Molding - Scratch - Minimal / (L) Rear Door, Molding - Scratch - Minimal / (L) Front Door, Molding - Scratch - Medium / (L) Step, In-panel, Side Spoiler - Scratch - Small |

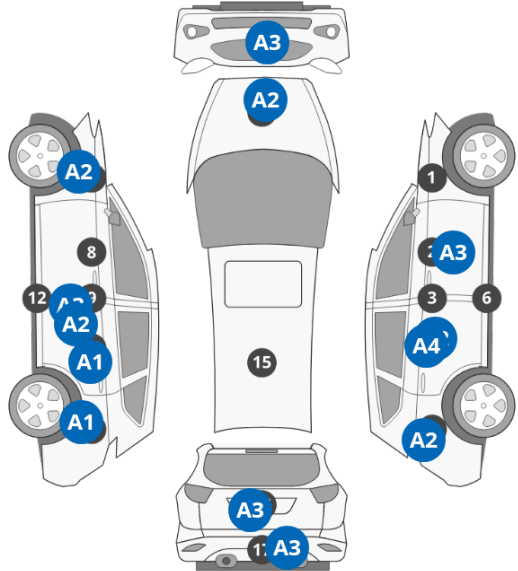
| Inspector Notes |
|---|
| Left rear molding glass crack. Without Seatcover, LTO plate. With warranty booklet, sparetire, jack, tools and 2keys. |
