## General Information

| Make | Toyota | Model | Hilux Tamaraw |
| Registration No. | NLA6894 | Chassis No. | PAHACACA9S6428063 |

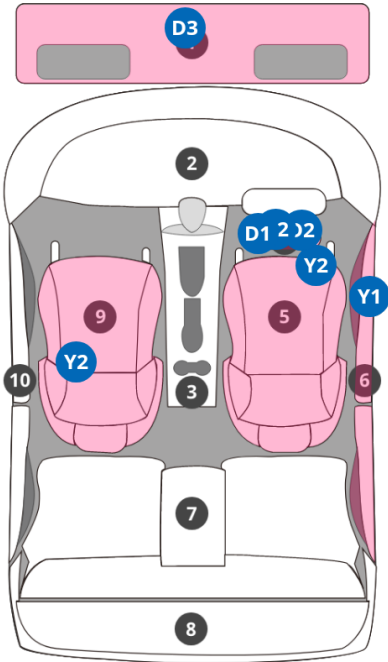
| Interior Evaluation : <b>B</b> | Exterior Evaluation : <b>E</b> |
| <p><b>Remarks</b></p> <p>Ceiling - Loose, Deformed - Medium / (R) Front Trim - Grime - Minimal / (R) Front Seat - Grime - Small / (R) Front Floor Mat - Worked - Small / (L) Front Floor Mat - Worked - Small / Carpet - Worked - Minimal / (L) Front Seat - Grime - Small</p> | <p><b>Remarks</b></p> <p>Antennae - Damaged - Yes / (R) Front Fender, Molding - Scratch - Minimal / (R) Mirror - Scratch - Small / (R) Front Door, Molding - Scratch - Minimal / (R) Step, In-panel, Side Spoiler - Scratch - Minimal / (R) Side Gate - Scratch - Large / Rear Bumper, Lamps, Panels - Scratch &amp; Dent - Small / Cargo Bed Floor - Scratch - Large / Rear Gate - Scratch &amp; Dent - Minimal / (L) Side Gate - Scratch - Large / (L) Front Door, Molding - Scratch - Medium / (L) Mirror - Scratch - Minimal / (L) Step, In-panel, Side Spoiler - Scratch - Minimal / Front Bumper, Grille, Lamps - Crack, Gap - Large / Bonnet, Headlight - Scratch &amp; Dent - Large / (L) Front Fender, Molding - Scratch &amp; Dent - Large / Front Windshield - Scratch, Stone chip - Medium</p> |

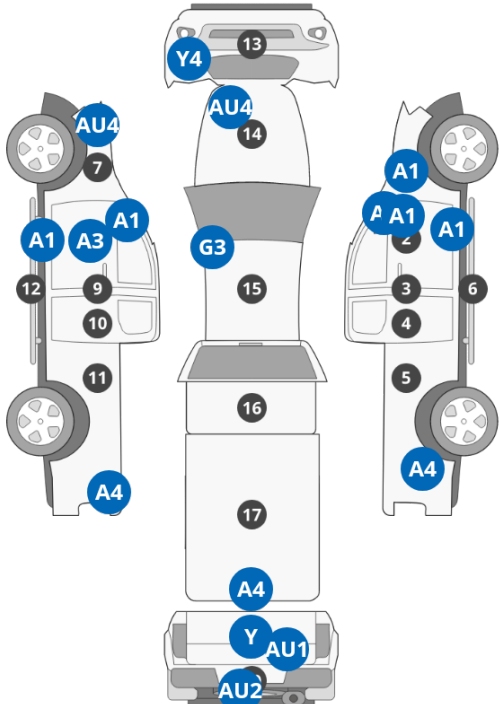
| Inspector Notes |
|---|
| With Lto plate.,with spare tire and warranty booklet, 1key, no jack and tools, cracked headlight and taillight,hood issue |
