## General Information

| Make | Toyota | Model | Hilux Tamaraw |
| YOM | 2026 | Odo Meter Reading | 21,595 |
| Registration No. | CDA8082 | Chassis No. | PAHACACA0S6429232 |

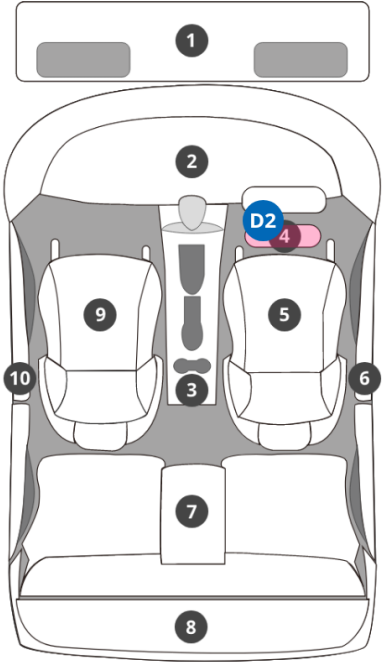
| Interior Evaluation : <span style="color: red; font-weight: bold;">A</span> | Exterior Evaluation : <span style="color: red; font-weight: bold;">D</span> |
|---|---|
| <b>Remarks</b><br>(L) Front Floor Mat - Worked - Small | <b>Remarks</b><br>Front Bumper, Grille, Lamps - Scratch - Large / (L) Guard Frame - Scratch - Medium / Cargo Bed Floor - Scratch & Dent - Large / Rear Bumper, Lamps, Panels - Scratch & Dent - Medium / (R) Front Door, Molding - Dent - Small / Roof - Repair mark - Yes / Roof - Scratch & Dent - Medium / (L) Front Door, Molding - Scratch - Small / (L) Front Fender, Molding - Scratch - Minimal / (R) Side Gate - Scratch - Small / Rear Gate - Scratch - Small |
