## General Information

Date & Time: 24, Feb, 2025 10:52

| Make | Toyota | Model | Vios |
| YOM | 2017 | Mileage | 75,187 |

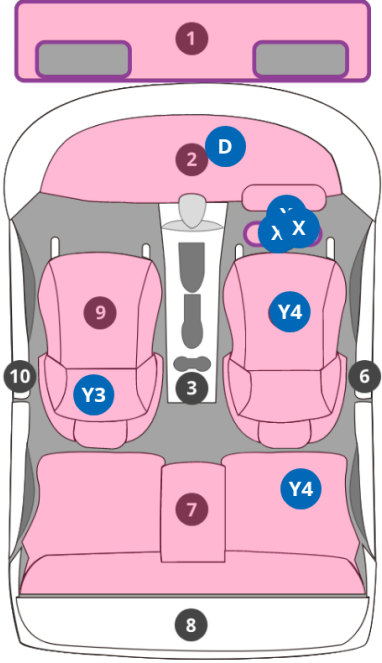
| Interior Evaluation : <b>C</b> | Exterior Evaluation : <b>C</b> |
|---|---|
| <b>Remarks</b><br>Rear Seat - Grime - Large / (R) Front Seat - Grime - Large / (L) Front Seat - Grime - Medium / Dashboard - Traces of Adhesive Tape - Yes / (R) Front Floor Mat - Missing - Yes / (L) Front Floor Mat - Missing - Yes / Mat Other - Missing - Yes / Room Lamp - Missing - Yes | <b>Remarks</b><br>(R) Step - Repair Traces - Yes / (R) Front Fender - Repair Traces - Yes / Bonnet - Repair Traces - Yes / (L) Front Fender - Repair Traces - Yes / (L) Step - Repair Traces - Yes / (L) Rear Fender - Repair Traces - Yes / (R) Rear Fender - Repair Traces - Yes / Roof - Repair Traces - Yes / (R) Rear Door, Molding - Scratch - Minimal / (R) Front Door, Molding - Scratch - Small / Rear Bumper, Lamps, Panels - Crack, Gap - Medium / (L) Rear Fender, Molding - Dent - Small / (L) Rear Door, Molding - Scratch - Minimal / (L) Front Fender, Molding - Scratch - Small / Bonnet, Headlight - Dent - Small / Roof - Scratch - Small / Front Bumper, Grille, Lamps - Crack, Gap - Medium |
