## General Information

| Make | Mitsubishi | Model | Mirage |
| YOM | 2022 | Odo Meter Reading | 63,036 |
| Registration No. | GAR8412 | Chassis No. | PAEA13RXNMA013961 |

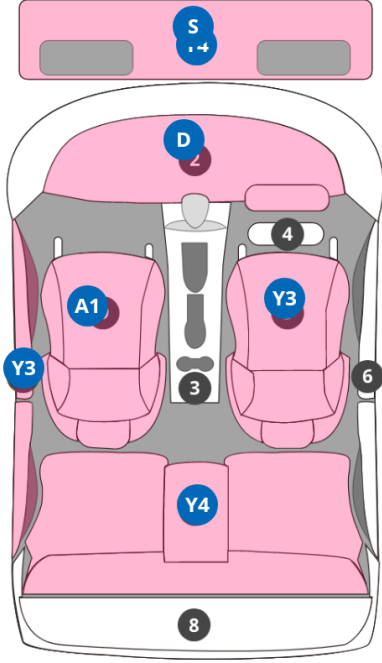
| Interior Evaluation : <b>C</b> | Exterior Evaluation : <b>E</b> |
|---|---|
| <p><b>Remarks</b><br/>(L) Front Trim - Grime - Medium / (R) Front Seat - Grime - Medium / Ceiling - Grime - Large / Rear Seat - Grime - Large / (L) Front Seat - Cut, Crack - Minimal / Dashboard - Traces of Adhesive Tape - Yes / Overall Interior - Smell - Yes</p> | <p><b>Remarks</b><br/>(R) Front Door - Repair Traces - Yes / (R) Front Fender - Repair Traces - Yes / (L) Front Fender - Repair Traces - Yes / (L) Front Door - Repair Traces - Yes / (L) Rear Door - Repair Traces - Yes / (R) Rear Fender - Repair Traces - Yes / (R) Rear Door - Repair Traces - Yes / Roof - Repair Traces - Yes / (R) Front Fender, Molding - Scratch &amp; Dent - Medium / (R) Front Door, Molding - Scratch &amp; Dent - Medium / (R) Front Door, Molding - Repair mark - Difference in Color / (R) Rear Door, Molding - Repair mark - Difference in Color / (R) Rear Door, Molding - Scratch - Medium / (R) Rear Fender, Molding - Scratch - Small / (L) Front Fender, Molding - Crack, Gap - Medium / (L) Mirror - Scratch - Minimal / (L) Front Door, Molding - Rust, Corrosion - Medium / (L) Rear Door, Molding - Dent - Medium / (L) Rear Fender, Molding - Scratch &amp; Dent - Medium / Front Bumper, Grille, Lamps - Crack, Gap - Large / Bonnet, Headlight - Scratch &amp; Dent - Small / Trunk Hood, Rear Gate - Rust, Corrosion - Medium / Rear Bumper, Lamps, Panels - Rust, Corrosion - Medium</p> |
