## General Information

| Make | Suzuki | Model | Carry |
| Registration No. | NHD2777 | Chassis No. | MHYDC61T4PJ211318 |

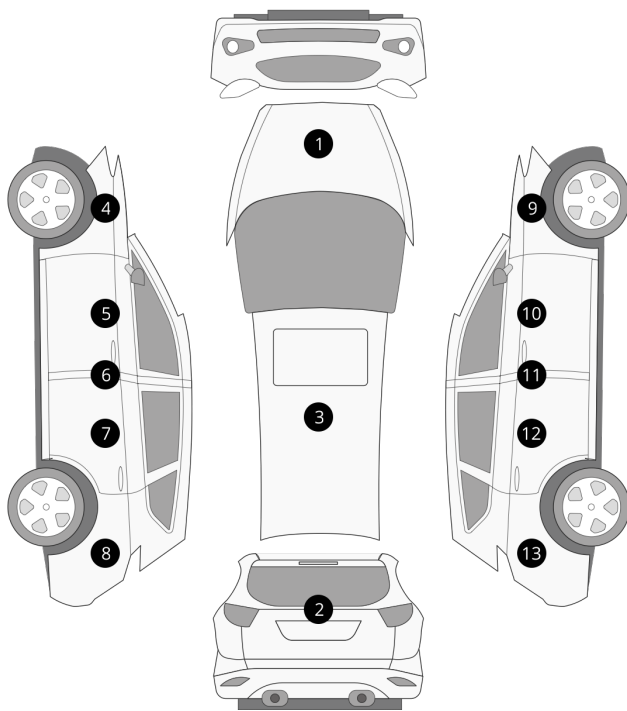
## Body / Panel Condition

| # | Area | Thickness(um) | | | |
|---|---|---|---|---|---|
| 8 | Left Back Panel | 152.6 | 192 | 133 | 133 |
| 13 | Right Back Panel | 214.6 | 158 | 298 | 188 |

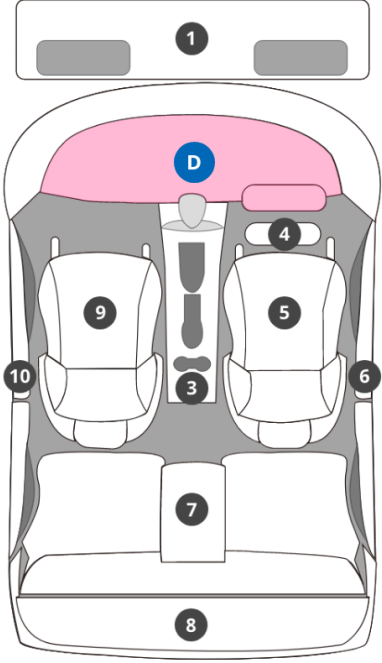
| Interior Evaluation : <span style="color: red; font-weight: bold;">A</span> | Exterior Evaluation : <span style="color: red; font-weight: bold;">E</span> |
| <b>Remarks</b><br>Dashboard - Traces of Adhesive Tape - Yes | <b>Remarks</b><br>(L) Rear Corner Panel - Repair Traces - Yes / (R) Rear Corner Panel - Repair Traces - Yes / Rear Bumper, Lamps, Panels - Scratch - Large / (L) Side Gate - Scratch - Large / (R) Side Gate - Scratch & Dent - Large / Front Bumper, Grille, Lamps - Repair mark - Yes / Front Bumper, Grille, Lamps - Scratch - Medium / (L) Front Door, Molding - Scratch & Dent - Medium / Roof - Dent - Medium / Cargo Bed Floor - Scratch - Large |
