## General Information

| Make | Toyota | Model | Hilux Tamaraw |
| Registration No. | NJK3040 | Chassis No. | PAHACACA1S6428266 |

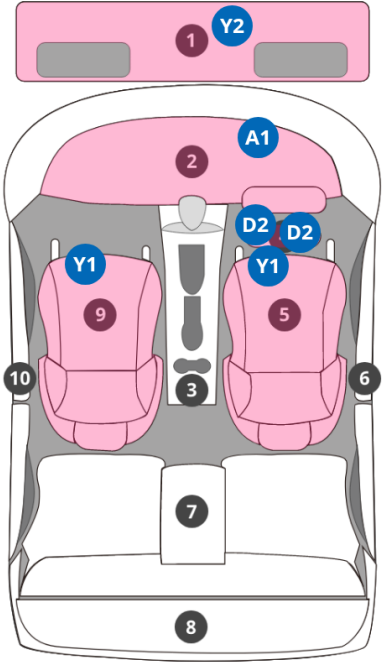
| Interior Evaluation : <b>A</b> | Exterior Evaluation : <b>E</b> |
| <b>Remarks</b><br>Dashboard - Worn, Scratch, Cut, Crack - Minimal / (R)<br>Front Seat - Grime - Minimal / (L) Front Seat - Grime - Minimal / (L) Front Floor Mat - Worked - Small / (R) Front Floor Mat - Worked - Small / Ceiling - Grime - Small | <b>Remarks</b><br>(R) Front Door - Repair Traces - Yes / (R) Front Fender - Repair Traces - Yes / Bonnet - Repair Traces - Yes / (L) Front Fender - Repair Traces - Yes / (L) Front Door - Repair Traces - Yes / Roof - Repair Traces - Yes / (R) Front Fender, Molding - Scratch - Small / (R) Front Door, Molding - Dent - Large / (R) Side Gate - Scratch & Dent - Large / (R) Step, In-panel, Side Spoiler - Scratch - Small / Rear Bumper, Lamps, Panels - Scratch - Small / Rear Gate - Scratch - Small / Cargo Bed Floor - Scratch - Large / (L) Side Gate - Scratch - Medium / (L) Front Door, Molding - Scratch - Small / (L) Front Fender, Molding - Scratch - Small / (L) Step, In-panel, Side Spoiler - Scratch - Minimal / Bonnet, Headlight - Scratch - Small / Front Bumper, Grille, Lamps - Scratch - Medium / Roof - Dent - Large |

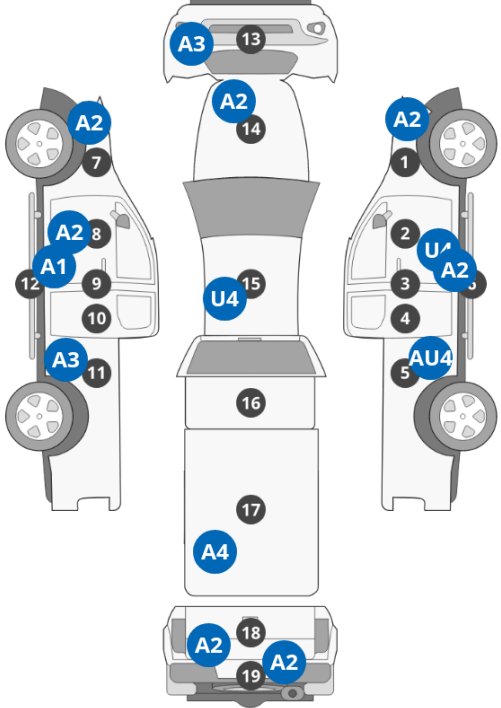
| Inspector Notes |
|---|
| with Ito plate/with spare tire/with warranty booklet/with spare key/with dent and scratches on the body/unable to identify functional due to non moving unit no key/non moving unit no key/taillight damage |
