## General Information

| Make | Suzuki | Model | APV |
| YOM | 2022 | Mileage | 54,639 |
| Registration No. | NHB2539 | Chassis No. | MHYDN71V5PJ401078 |

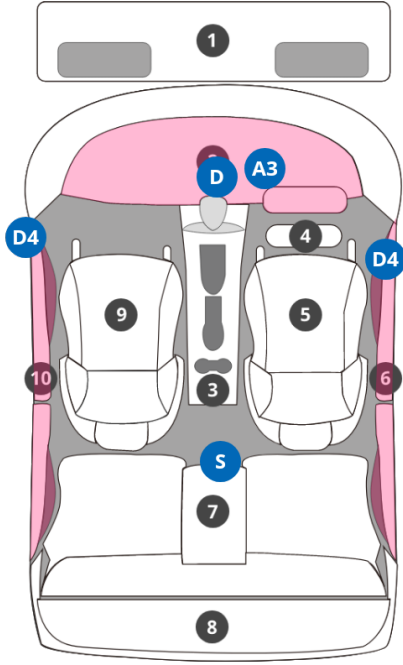
| Interior Evaluation : <b>C</b> | Exterior Evaluation : <b>E</b> |
| <p><b>Remarks</b></p> <p>Dashboard - Traces of Adhesive Tape - Yes / Glove Box - Worn, Scratch, Cut, Crack - Medium / Overall Interior - Smell - Yes / (R) Front Trim - Worked - Large / (L) Front Trim - Worked - Large</p> | <p><b>Remarks</b></p> <p>Front Bumper, Grille, Lamps - Scratch - Large / (L) Front Fender, Molding - Scratch - Medium / (L) Rear Door, Molding - Dent - Small / (L) Rear Fender, Molding - Dent - Small / Trunk Hood, Rear Gate - Scratch - Medium / Rear Bumper, Lamps, Panels - Scratch - Large / (R) Rear Fender, Molding - Scratch &amp; Dent - Large / (R) Rear Door, Molding - Dent - Small / (R) Front Door, Molding - Scratch &amp; Dent - Large / (R) Step, In-panel, Side Spoiler - Scratch - Small / Bonnet, Headlight - Scratch - Medium / Roof - Dent - Small</p> |
