## General Information

| Make | Toyota | Model | Fortuner |
| Registration No. | DBI218 | Chassis No. | MHFCB8GS5P3527235 |

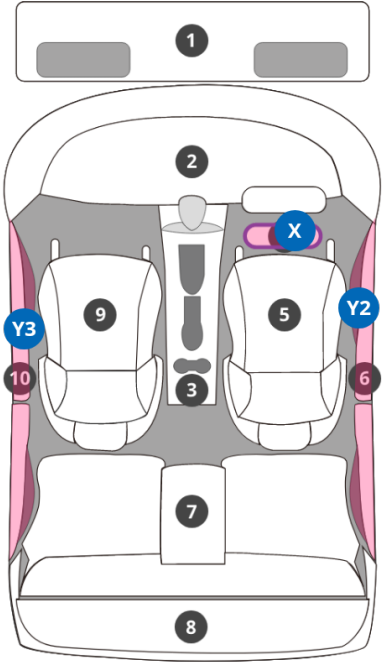
| Interior Evaluation : <b>B</b> | Exterior Evaluation : <b>D</b> |
| <b>Remarks</b><br>(L) Front Trim - Grime - Medium / Mat Other - Missing - Yes / (R) Front Trim - Grime - Small | <b>Remarks</b><br>(R) Step - Repair Traces - Yes / (L) Rear Fender - Repair Traces - Yes / Trunk Hood, Rear Gate - Repair Traces - Yes / Roof - Repair Traces - Yes / (R) Rear Door, Molding - Dent - Medium / Trunk Hood, Rear Gate - Repair mark - Yes / Rear Bumper, Lamps, Panels - Scratch & Dent - Small / (L) Rear Door, Molding - Dent - Small / (L) Front Door, Molding - Dent - Small / (L) Step, In-panel, Side Spoiler - Scratch - Medium / (R) Front Door, Molding - Dent - Small / Roof - Dent - Medium / (L) Rear Fender, Molding - Dent - Small / Front Bumper, Grille, Lamps - Scratch - Small / Trunk Hood, Rear Gate - Scratch - Small / Trunk Hood, Rear Gate - Partially Missing - Yes / (R) Rear Door, Molding - Repair mark - Yes |
