## General Information

| Make | Toyota | Model | Vios |
| YOM | 2023 | Odo Meter Reading | 124,578 |
| Registration No. | NIS4517 | Chassis No. | PA1B18F38P4220788 |

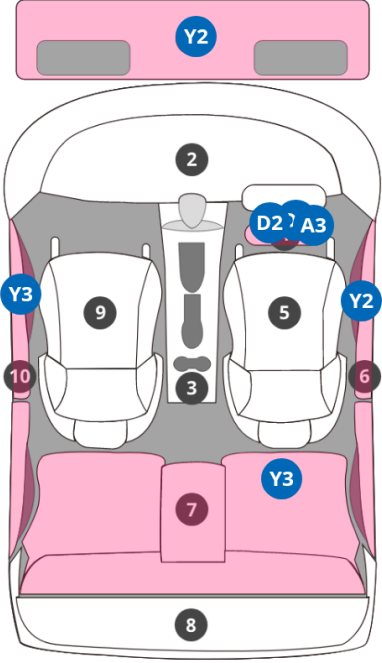
| Interior Evaluation : <b>C</b> | Exterior Evaluation : <b>E</b> |
| <p><b>Remarks</b><br/>Ceiling - Grime - Small / Rear Seat - Grime - Medium / Carpet - Worked - Large / (R) Front Trim - Grime - Small / (R) Front Floor Mat - Worked - Small / (L) Front Trim - Grime - Medium / (L) Front Floor Mat - Cut, Crack - Medium</p> | <p><b>Remarks</b><br/>(R) Front Door - Repair Traces - Yes / (R) Front Fender - Repair Traces - Yes / Bonnet - Repair Traces - Yes / (R) Front Fender, Molding - Repair mark - Yes / (R) Front Fender, Molding - Scratch &amp; Dent - Small / (R) Mirror - Scratch - Minimal / (R) Front Door, Molding - Repair mark - Yes / (R) Front Door, Molding - Scratch - Minimal / (R) Step, In-panel, Side Spoiler - Scratch &amp; Dent - Large / (R) Rear Door, Molding - Scratch &amp; Dent - Medium / (R) Rear Fender, Molding - Scratch - Small / Rear Bumper, Lamps, Panels - Scratch &amp; Dent - Large / Trunk Hood, Rear Gate - Scratch &amp; Dent - Large / (L) Rear Fender, Molding - Scratch &amp; Dent - Small / (L) Rear Door, Molding - Scratch &amp; Dent - Large / (L) Front Door, Molding - Scratch &amp; Dent - Large / (L) Step, In-panel, Side Spoiler - Scratch - Minimal / (L) Mirror - Scratch - Small / (L) Front Fender, Molding - Scratch &amp; Dent - Medium / Front Bumper, Grille, Lamps - Scratch &amp; Dent - Medium / Bonnet, Headlight - Scratch - Minimal / Roof - Scratch &amp; Dent - Minimal</p> |
