## General Information

| Make | Toyota | Model | Avanza |
| Registration No. | NHT2034 | Chassis No. | MHFAA1BY2S0038847 |

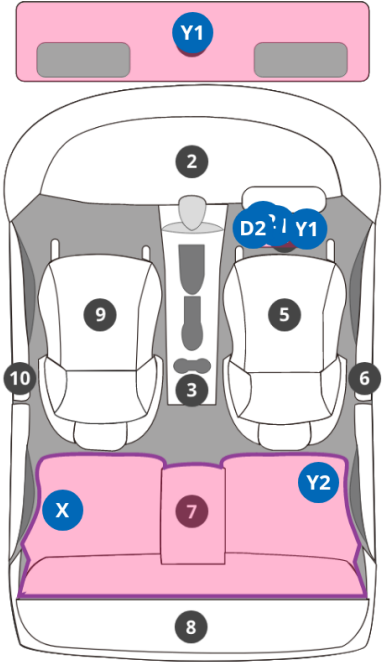
| Interior Evaluation : <span style="color: red;">C</span> | Exterior Evaluation : <span style="color: red;">E</span> |
| <b>Remarks</b><br>Rear Seat - Grime - Small / (R) Front Floor Mat - Grime - Minimal / Ceiling - Grime - Minimal / Carpet - Worked - Minimal / (L) Front Floor Mat - Worked - Small / Mat Other - Worked - Small / Rear Seat - Partially Missing - Yes | <b>Remarks</b><br>(R) Front Door - Repair Traces - Yes / (R) Step - Repair Traces - Yes / (R) Front Fender - Repair Traces - Yes / (L) Front Fender - Repair Traces - Yes / (L) Front Door - Repair Traces - Yes / (L) Rear Door - Repair Traces - Yes / (L) Rear Fender - Repair Traces - Yes / Trunk Hood, Rear Gate - Repair Traces - Yes / (R) Rear Fender - Repair Traces - Yes / (R) Rear Door - Repair Traces - Yes / Roof - Repair Traces - Yes / (R) Front Fender, Molding - Scratch - Medium / (R) Mirror - Scratch - Minimal / (R) Front Door, Molding - Scratch - Minimal / (R) Rear Door, Molding - Repair mark - Yes / (R) Step, In-panel, Side Spoiler - Repair mark - Yes / (R) Rear Fender, Molding - Repair mark - Yes / (R) Rear Door, Molding - Scratch - Minimal / (R) Step, In-panel, Side Spoiler - Scratch & Dent - Large / (R) Rear Fender, Molding - Scratch - Minimal / Rear Bumper, Lamps, Panels - Scratch - Minimal / Trunk Hood, Rear Gate - Scratch - Minimal / (L) Rear Fender, Molding - Scratch & Dent - Minimal / (L) Rear Door, Molding - Scratch - Minimal / (L) Front Door, Molding - Scratch - Minimal / (L) Step, In-panel, Side Spoiler - Scratch - Minimal / (L) Mirror - Scratch - Minimal / Front Bumper, Grille, Lamps - Crack, Gap - Large / Bonnet, Headlight - Scratch - Minimal / (R) Mirror - Crack - Damaged / (R) Front Fender, Molding - Repair mark - Yes / (L) Front Fender, Molding - Scratch - Minimal |
