## General Information

| Make | Lexus | Model | ES |
| Registration No. | MLB575 | Chassis No. | JTHBK1GG602010062 |

## Body / Panel Condition

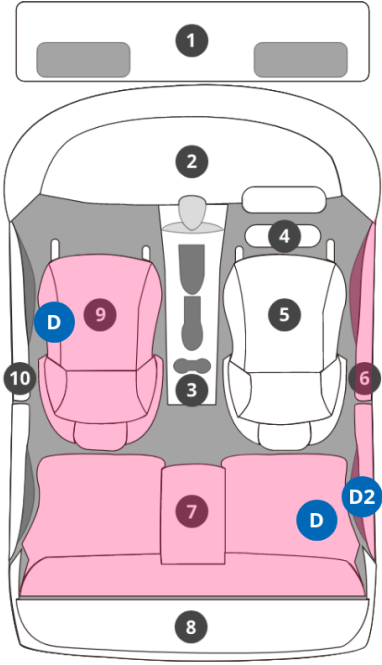
| Interior Evaluation : <span style="color: red;">C</span> | Exterior Evaluation : <span style="color: red;">C</span> |
| <b>Remarks</b><br>(L) Front Seat - Worn - Yes / Overall Interior - Worn as per age - Yes / (R) Rear Trim - Worked - Small / Rear Seat - Worn - Yes | <b>Remarks</b><br>(R) Front Door - Repair Traces - Yes / (R) Step - Repair Traces - Yes / Bonnet - Repair Traces - Yes / (L) Front Fender - Repair Traces - Yes / (L) Step - Repair Traces - Yes / Trunk Hood, Rear Gate - Repair Traces - Yes / (R) Rear Fender, Molding - Dent - Small / Front Bumper, Grille, Lamps - Crack, Gap - Medium / (R) Step, In-panel, Side Spoiler - Scratch - Large / (L) Front Door, Molding - Scratch & Dent - Small / (L) Rear Door, Molding - Scratch & Dent - Small / Rear Bumper, Lamps, Panels - Scratch - Small / (R) Rear Door, Molding - Scratch - Small / (L) Step, In-panel, Side Spoiler - Scratch - Small |
