## General Information

| Make | Toyota | Model | Innova |

## Body / Panel Condition

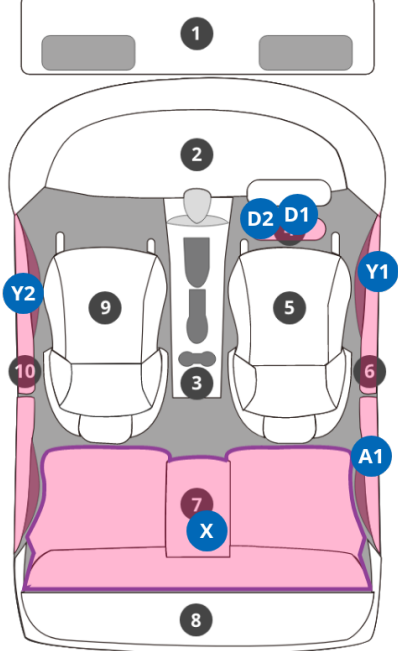
| Interior Evaluation : <span style="color: red;">C</span> | Exterior Evaluation : <span style="color: red;">D</span> |
|---|---|
| <b>Remarks</b><br>Rear Seat Head Rest - Partially Missing - Yes / (R) Front Trim - Grime - Minimal / Trim Other - Cut, Crack - Minimal / (L) Front Trim - Grime - Small / (L) Front Floor Mat - Worked - Small / Carpet - Worked - Minimal | <b>Remarks</b><br>Trunk Hood, Rear Gate - Repair Traces - Yes / (R) Front Fender, Molding - Scratch - Small / (R) Mirror - Scratch - Minimal / (R) Front Door, Molding - Scratch - Medium / (R) Step, In-panel, Side Spoiler - Scratch - Minimal / (R) Rear Door, Molding - Scratch - Medium / (R) Rear Fender, Molding - Scratch - Minimal / Rear Bumper, Lamps, Panels - Crack, Gap - Large / Trunk Hood, Rear Gate - Repair mark - Yes / Trunk Hood, Rear Gate - Scratch & Dent - Small / (L) Rear Fender, Molding - Scratch - Medium / (L) Front Door, Molding - Scratch - Minimal / (L) Step, In-panel, Side Spoiler - Scratch - Minimal / Bonnet, Headlight - Scratch - Minimal / (L) Mirror - Scratch - Minimal / (L) Front Fender, Molding - Scratch - Small / Front Bumper, Grille, Lamps - Scratch - Medium / Roof - Scratch - Minimal / (L) Rear Door, Molding - Scratch - Minimal |
