## General Information

| Make | Toyota | Model | Lite Ace |
| Registration No. | FAQ9368 | Chassis No. | MHKU3FE10RK008841 |

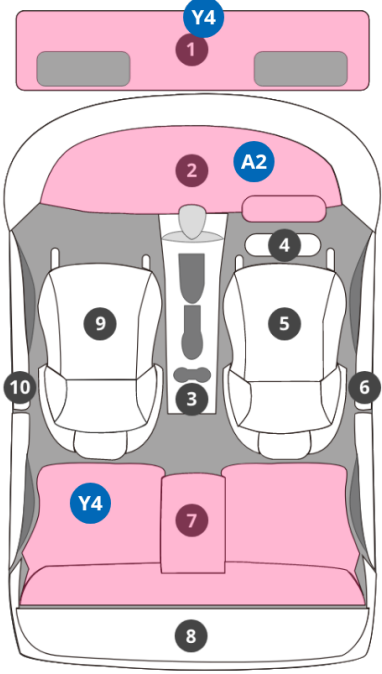
| Interior Evaluation : <span style="color: red;">C</span> | Exterior Evaluation : <span style="color: red;">D</span> |
| <b>Remarks</b><br>Ceiling - Grime - Large / Dashboard - Worn, Scratch, Cut, Crack - Small / Rear Seat - Grime - Large | <b>Remarks</b><br>(R) Step, In-panel, Side Spoiler - Scratch - Medium / (R) Front Door, Molding - Scratch & Dent - Medium / (R) Side Gate - Repair mark - Yes / Rear Gate - Repair mark - Yes / Rear Gate - Scratch & Dent - Medium / (L) Side Gate - Repair mark - Yes / (L) Front Fender, Molding - Scratch - Minimal / Front Bumper, Grille, Lamps - Scratch - Large / Cargo Bed Floor - Scratch - Large |
