## General Information

| Make | Toyota | Model | Hilux Tamaraw |
| Registration No. | FBA1055 | Chassis No. | PAHACACA5S6430831 |

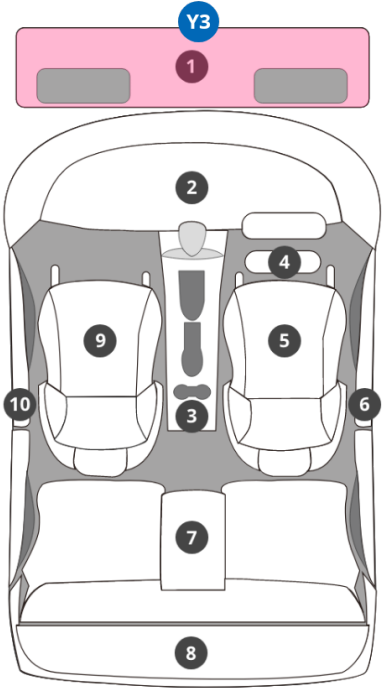
| Interior Evaluation : <b>B</b> | Exterior Evaluation : <b>C</b> |
| <b>Remarks</b><br>Ceiling - Grime - Medium | <b>Remarks</b><br>(R) Front Fender, Molding - Scratch - Minimal / (R) Front Door, Molding - Scratch & Dent - Minimal / (R) Side Gate - Scratch & Dent - Small / Rear Gate - Scratch - Minimal / Rear Bumper, Lamps, Panels - Scratch - Large / Cargo Bed Floor - Rust, Corrosion - Large / (L) Side Gate - Scratch & Dent - Large / (L) Front Fender, Molding - Scratch - Small |
