## General Information

| Make | Hyundai | Model | Accent |
| Registration No. | NDX8185 | Chassis No. | KMHCT41UGGU060623 |

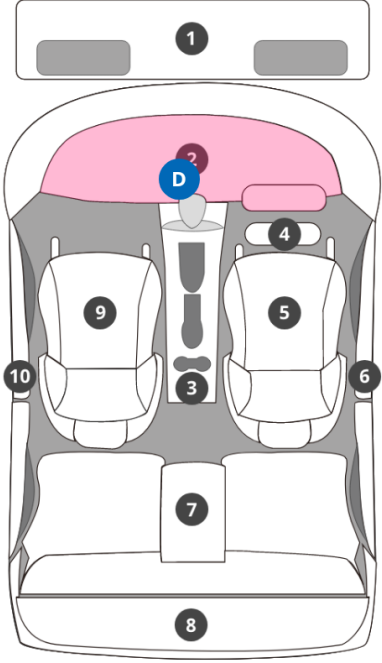
| Interior Evaluation : <b>C</b> | Exterior Evaluation : <b>E</b> |
| <p><b>Remarks</b><br/>Dashboard - Repair Mark - Yes / Overall Interior - Worn as per age - Yes</p> | <p><b>Remarks</b><br/>(R) Front Door - Repair Traces - Yes / (R) Front Fender - Repair Traces - Yes / Bonnet - Repair Traces - Yes / (L) Front Fender - Repair Traces - Yes / (L) Front Door - Repair Traces - Yes / (L) Step - Repair Traces - Yes / (L) Rear Door - Repair Traces - Yes / (L) Rear Fender - Repair Traces - Yes / Trunk Hood, Rear Gate - Repair Traces - Yes / (R) Rear Fender - Repair Traces - Yes / (R) Rear Door - Repair Traces - Yes / Roof - Repair Traces - Yes / Front Bumper, Grille, Lamps - Scratch &amp; Dent - Large / (R) Front Fender, Molding - Scratch &amp; Dent - Medium / (R) Rear Fender, Molding - Dent - Small / Rear Bumper, Lamps, Panels - Scratch - Large / (L) Front Door, Molding - Dent - Small / (L) Step, In-panel, Side Spoiler - Dent - Small / (L) Front Door, Molding - Dent - Small / (L) Front Fender, Molding - Modified - Medium / (R) Front Fender, Molding - Modified - Medium / Trunk Hood, Rear Gate - Scratch - Small / (R) Front Door, Molding - Dent - Small / (R) Rear Door, Molding - Dent - Small</p> |
