## General Information

| Make | Mitsubishi | Model | Strada |
| YOM | 2017 | Odo Meter Reading | 105,804 |
| Registration No. | DAF1355 | Chassis No. | MMBJYKK10HH014547 |

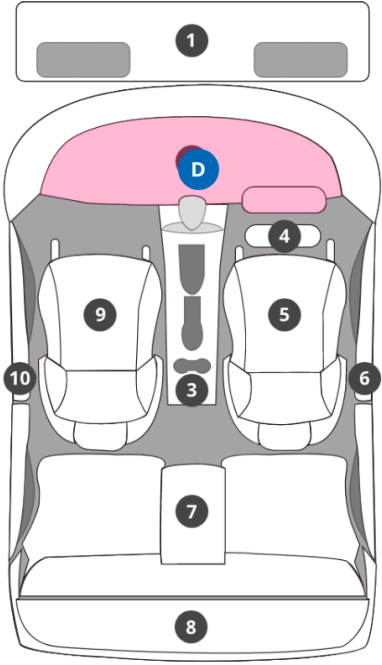
| Interior Evaluation : <b>C</b> | Exterior Evaluation : <b>E</b> |
|---|---|
| <p><b>Remarks</b><br/>Dashboard - Traces of Adhesive Tape - Yes / Overall Interior - Worn as per age - Yes</p> | <p><b>Remarks</b><br/>(R) Front Door - Repair Traces - Yes / (R) Step - Repair Traces - Yes / (R) Front Fender - Repair Traces - Yes / Bonnet - Repair Traces - Yes / (L) Front Fender - Repair Traces - Yes / (L) Front Door - Repair Traces - Yes / (L) Step - Repair Traces - Yes / (L) Rear Door - Repair Traces - Yes / (L) Rear Corner Panel - Repair Traces - Yes / (R) Rear Door - Repair Traces - Yes / Roof - Repair Traces - Yes / (L) Front Door, Molding - Scratch &amp; Dent - Large / (L) Rear Door, Molding - Dent - Small / (L) Side Gate - Scratch - Small / Rear Bumper, Lamps, Panels - Crack, Gap - Large / Rear Gate - Scratch &amp; Dent - Small / (R) Side Gate - Scratch &amp; Dent - Large / (R) Rear Door, Molding - Scratch - Large / (R) Step, In-panel, Side Spoiler - Scratch - Small / Front Bumper, Grille, Lamps - Scratch &amp; Dent - Large / Roof - Dent - Medium / (R) Front Door, Molding - Scratch - Small</p> |
