## General Information

| Make | Toyota | Model | Hiace |
| Registration No. | EAJ1404 | Chassis No. | JTFJT02P1P5035267 |

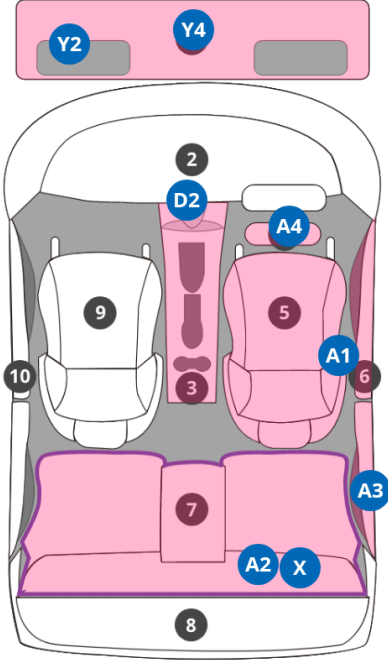
| Interior Evaluation : <b>C</b> | Exterior Evaluation : <b>E</b> |
| <p><b>Remarks</b></p> <p>Ceiling - Grime - Large / Rear Seat - Partially Missing - Yes / Carpet - Worn, Scratch, Cut, Crack - Large / Trim Other - Cut, Crack - Medium / Rear Seat - Cut, Crack - Small / (R) Front Seat belt - Cut, Crack - Minimal / Sunvisor, Sunglass Holder - Grime - Small / Console, Switchs, Vents - Loose, Deformed - Small</p> | <p><b>Remarks</b></p> <p>(L) Front Fender - Repair Traces - Yes / (R) Rear Door - Repair Traces - Yes / (R) Front Fender, Molding - Scratch - Minimal / (R) Front Door, Molding - Scratch &amp; Dent - Medium / (R) Step, In-panel, Side Spoiler - Crack, Gap - Medium / (R) Center Panel - Scratch &amp; Dent - Minimal / (R) Rear Door, Molding - Scratch - Small / (R) Rear Fender, Molding - Scratch - Minimal / Roof - Scratch &amp; Dent - Large / Rear Bumper, Lamps, Panels - Scratch - Minimal / Trunk Hood, Rear Gate - Scratch &amp; Dent - Minimal / (L) Rear Fender, Molding - Scratch &amp; Dent - Small / (L) Front Door, Molding - Scratch &amp; Dent - Large / (L) Front Fender, Molding - Scratch &amp; Dent - Small / (L) Step, In-panel, Side Spoiler - Scratch - Minimal / Bonnet, Headlight - Scratch &amp; Dent - Small / Front Bumper, Grille, Lamps - Crack, Gap - Large / (L) Mirror - Scratch - Minimal</p> |
