## General Information

| Make | Toyota | Model | Vios |
| YOM | 2023 | Odo Meter Reading | 105,580 |
| Registration No. | NFC8362 | Chassis No. | PA1B18F37P4220989 |

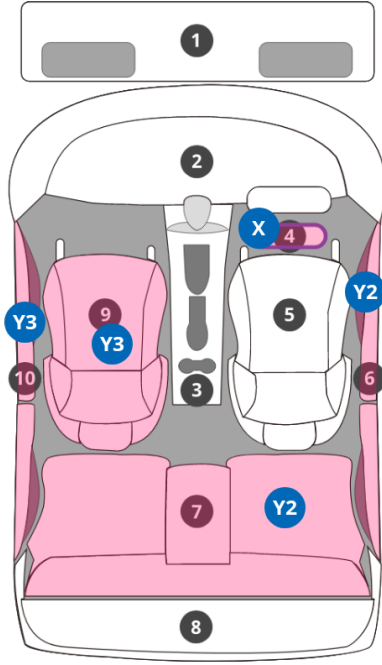
| Interior Evaluation : <b>B</b> | Exterior Evaluation : <b>E</b> |
|---|---|
| <p><b>Remarks</b><br/>(L) Front Trim - Grime - Medium / (R) Front Trim - Grime - Small / (L) Front Floor Mat - Missing - Yes / (L) Front Seat - Grime - Medium / Rear Seat - Grime - Small</p> | <p><b>Remarks</b><br/>(R) Front Fender - Repair Traces - Yes / (L) Front Fender - Repair Traces - Yes / (L) Front Door - Repair Traces - Yes / (L) Step - Repair Traces - Yes / Front Bumper, Grille, Lamps - Scratch &amp; Dent - Large / Bonnet, Headlight - Repair mark - Yes / Rear Bumper, Lamps, Panels - Scratch &amp; Dent - Large / (L) Rear Fender, Molding - Repair mark - Yes / Rear Bumper, Lamps, Panels - Repair mark - Yes / (L) Rear Fender, Molding - Scratch &amp; Dent - Medium / (L) Front Door, Molding - Scratch &amp; Dent - Small / (L) Rear Door, Molding - Scratch - Medium / Trunk Hood, Rear Gate - Crack, Gap - Large / (R) Rear Fender, Molding - Scratch - Medium / (R) Front Door, Molding - Scratch &amp; Dent - Small / (R) Rear Door, Molding - Scratch - Small / (R) Front Fender, Molding - Scratch - Small / Roof - Scratch &amp; Dent - Small</p> |
