## General Information

| Make | Toyota | Model | Wigo |
| Registration No. | CAM5315 | Chassis No. | MHKA4DF5FJJ018239 |

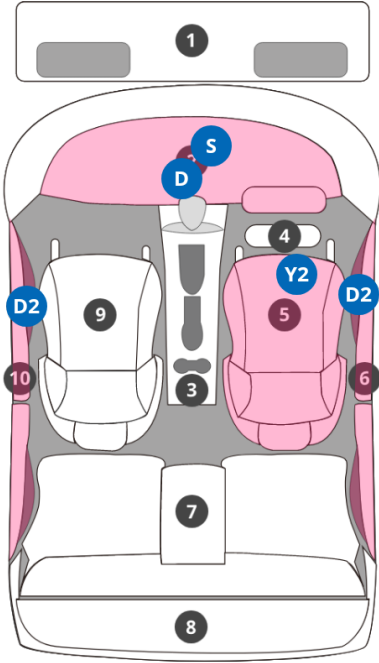
| Interior Evaluation : <b>B</b> | Exterior Evaluation : <b>E</b> |
|---|---|
| <p><b>Remarks</b></p> <p>Dashboard - Traces of Adhesive Tape - Yes / (R) Front Seat - Grime - Small / (L) Front Trim - Worked - Small / (R) Front Trim - Worked - Small / Overall Interior - Smell - Yes</p> | <p><b>Remarks</b></p> <p>(R) Front Door - Repair Traces - Yes / (R) Step - Repair Traces - Yes / (R) Front Fender - Repair Traces - Yes / Bonnet - Repair Traces - Yes / (L) Front Fender - Repair Traces - Yes / (L) Front Door - Repair Traces - Yes / (L) Step - Repair Traces - Yes / (L) Rear Door - Repair Traces - Yes / (L) Rear Fender - Repair Traces - Yes / Trunk Hood, Rear Gate - Repair Traces - Yes / (R) Rear Fender - Repair Traces - Yes / (R) Rear Door - Repair Traces - Yes / Roof - Repair Traces - Yes / (L) Rear Fender, Molding - Scratch &amp; Dent - Large / Rear Bumper, Lamps, Panels - Scratch &amp; Dent - Large / Trunk Hood, Rear Gate - Dent - Small / (R) Rear Fender, Molding - Scratch &amp; Dent - Medium / (R) Rear Door, Molding - Scratch &amp; Dent - Large / (R) Front Door, Molding - Scratch &amp; Dent - Medium / (R) Step, In-panel, Side Spoiler - Scratch &amp; Dent - Medium / Front Bumper, Grille, Lamps - Repair mark - Yes / Rear Bumper, Lamps, Panels - Repair mark - Yes / Front Bumper, Grille, Lamps - Crack, Gap - Large / Bonnet, Headlight - Dent - Small / (R) Front Fender, Molding - Scratch &amp; Dent - Small / (L) Front Door, Molding - Scratch &amp; Dent - Large / (L) Rear Door, Molding - Scratch - Large / Roof - Scratch &amp; Dent - Medium / Roof Spoiler, Molding - Scratch - Small</p> |
