## General Information

| Make | Hyundai | Model | Accent |
| Registration No. | FAE3029 | Chassis No. | KMHCT41BEJU431859 |

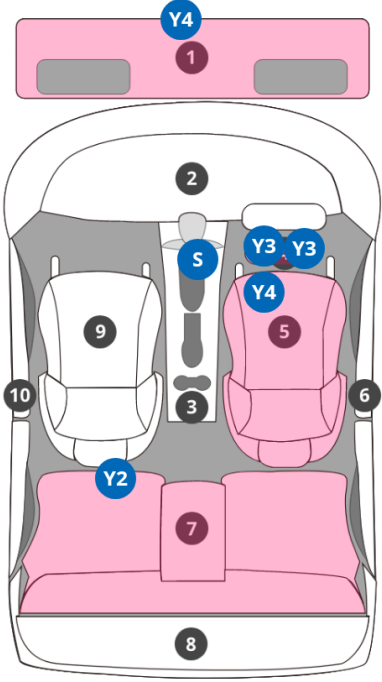
| Interior Evaluation : <b>C</b> | Exterior Evaluation : <b>E</b> |
|---|---|
| <p><b>Remarks</b><br/>(R) Front Seat - Grime - Large / (R) Front Floor Mat - Grime - Medium / (L) Front Floor Mat - Grime - Medium / Rear Seat - Grime - Small / Ceiling - Grime - Large / Overall Interior - Smell - Yes</p> | <p><b>Remarks</b><br/>(R) Step - Repair Traces - Yes / (L) Front Fender - Repair Traces - Yes / (L) Step - Repair Traces - Yes / Trunk Hood, Rear Gate - Repair Traces - Yes / (R) Front Fender, Molding - Modified - Medium / (R) Front Fender, Molding - Repair mark - Yes / (R) Mirror - Scratch - Small / (R) Front Door, Molding - Scratch - Medium / (R) Step, In-panel, Side Spoiler - Scratch - Large / (R) Rear Door, Molding - Scratch - Large / (R) Rear Fender, Molding - Modified - Large / Rear Bumper, Lamps, Panels - Repair mark - Yes / Rear Bumper, Lamps, Panels - Crack, Gap - Large / Trunk Hood, Rear Gate - Dent - Medium / (L) Rear Fender, Molding - Modified - Large / (L) Rear Door, Molding - Scratch - Large / (L) Front Door, Molding - Scratch - Small / (L) Front Fender, Molding - Modified - Large / Front Bumper, Grille, Lamps - Repair mark - Yes / Front Bumper, Grille, Lamps - Modified - Large / (L) Step, In-panel, Side Spoiler - Scratch &amp; Dent - Large</p> |
