## General Information

| Make | Mitsubishi | Model | Mirage |
| YOM | 2020 | Odo Meter Reading | 58,857 |
| Registration No. | CBK1189 | Chassis No. | PAEA13RJLLA016824 |

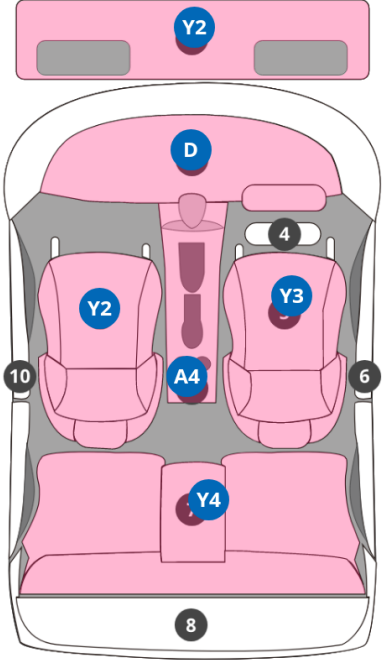
| Interior Evaluation : <b>C</b> | Exterior Evaluation : <b>E</b> |
| <p><b>Remarks</b></p> <p>Ceiling - Grime - Small / (R) Front Seat - Grime - Medium / Dashboard - Traces of Adhesive Tape - Yes / (L) Front Seat - Grime - Small / Rear Seat - Grime - Large / Console, Switches, Vents - Worn, Scratch, Cut, Crack - Large</p> | <p><b>Remarks</b></p> <p>(R) Front Fender - Repair Traces - Yes / Bonnet - Repair Traces - Yes / (L) Front Fender - Repair Traces - Yes / (R) Front Fender, Molding - Crack, Gap - Medium / (R) Mirror - Scratch - Small / (R) Front Door, Molding - Scratch - Medium / (R) Rear Door, Molding - Scratch &amp; Dent - Large / (R) Rear Fender, Molding - Scratch &amp; Dent - Large / (L) Front Fender, Molding - Repair mark - Difference in Color / (L) Front Fender, Molding - Scratch - Small / (L) Mirror - Scratch - Small / (L) Rear Door, Molding - Scratch &amp; Dent - Large / (L) Rear Fender, Molding - Scratch - Small / (L) Step, In-panel, Side Spoiler - Scratch &amp; Dent - Medium / Front Bumper, Grille, Lamps - Crack, Gap - Large / Bonnet, Headlight - Crack, Gap - Medium / Antennae - Damaged - Yes / Trunk Hood, Rear Gate - Scratch - Small / Rear Bumper, Lamps, Panels - Scratch &amp; Dent - Medium / (L) Front Door, Molding - Crack, Gap - Large</p> |
