## General Information

| Make | Nissan | Model | NV350 |
| Registration No. | NAN3097 | Chassis No. | JN1TC2E26Z0061630 |

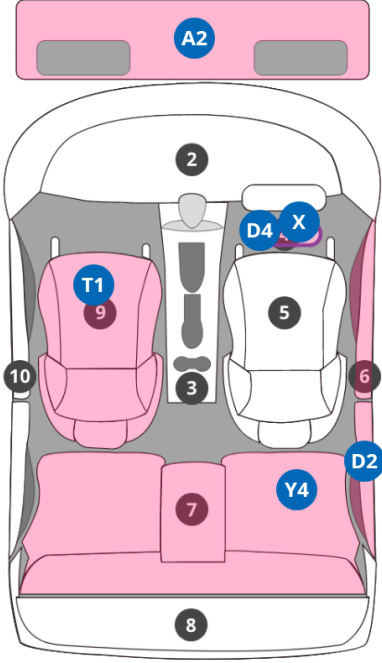
| Interior Evaluation : <b>C</b> | Exterior Evaluation : <b>C</b> |
| <p><b>Remarks</b></p> <p>(R) Front Floor Mat - Missing - Yes / Carpet - Worked - Large / Rear Seat - Grime - Large / Ceiling - Cut, Crack - Small / Trim Other - Worked - Small / (L) Front Seat - Cigarette Burns - Burnt Minimal</p> | <p><b>Remarks</b></p> <p>Front Panel - Repair Traces - Yes / (L) Rear Fender - Repair Traces - Yes / Trunk Hood, Rear Gate - Repair Traces - Yes / (R) Front Fender, Molding - Scratch - Minimal / (R) Mirror - Crack - Cracks / (R) Front Door, Molding - Scratch &amp; Dent - Minimal / (R) Step, In-panel, Side Spoiler - Scratch - Minimal / (R) Center Panel - Scratch - Minimal / (R) Rear Door, Molding - Scratch &amp; Dent - Minimal / (R) Rear Fender, Molding - Scratch &amp; Dent - Small / Rear Bumper, Lamps, Panels - Scratch - Small / Trunk Hood, Rear Gate - Scratch &amp; Dent - Small / (L) Rear Fender, Molding - Repair mark - Difference in Color / (L) Rear Fender, Molding - Scratch &amp; Dent - Medium / (L) Front Door, Molding - Scratch - Minimal / (L) Mirror - Scratch - Minimal / Front Bumper, Grille, Lamps - Scratch - Small / (L) Front Fender, Molding - Scratch - Minimal / Front Panel - Scratch - Minimal / (L) Step, In-panel, Side Spoiler - Scratch - Minimal / Roof - Scratch - Minimal</p> |

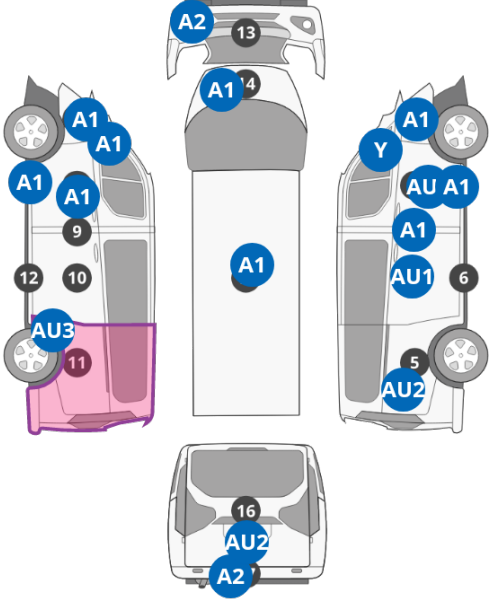
| Inspector Notes |
|---|
| With Lto plate, with jack, 1key, no spare tire and warranty booklet and tools, scratches on headlights, Crack taillight |
