## General Information

| Make | Subaru | Model | Forester |
| YOM | 2015 | Odo Meter Reading | 96,715 |
| Registration No. | ABT1423 | Chassis No. | JF1SJ5LC5EG148752 |

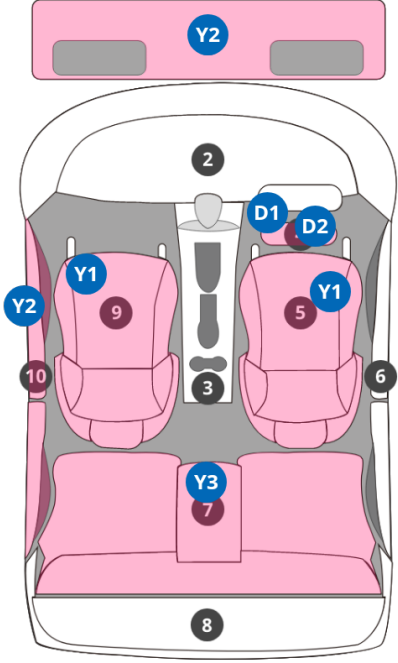
| Interior Evaluation : <b>B</b> | Exterior Evaluation : <b>D</b> |
|---|---|
| <p><b>Remarks</b></p> <p>Ceiling - Grime - Small / Rear Seat - Grime - Medium / (R) Front Seat - Grime - Minimal / (L) Front Trim - Grime - Small / (L) Front Floor Mat - Worked - Small / Carpet - Worked - Minimal / (L) Front Seat - Grime - Minimal</p> | <p><b>Remarks</b></p> <p>(R) Front Door - Repair Traces - Yes / (R) Front Fender - Repair Traces - Yes / Bonnet - Repair Traces - Yes / (L) Front Fender - Repair Traces - Yes / (L) Front Door - Repair Traces - Yes / (L) Rear Door - Repair Traces - Yes / (L) Rear Fender - Repair Traces - Yes / Trunk Hood, Rear Gate - Repair Traces - Yes / (R) Rear Fender - Repair Traces - Yes / (R) Rear Door - Repair Traces - Yes / Roof - Repair Traces - Yes / (R) Front Fender, Molding - Scratch &amp; Dent - Small / (R) Front Door, Molding - Scratch &amp; Dent - Small / (R) Step, In-panel, Side Spoiler - Scratch - Minimal / (R) Rear Door, Molding - Scratch - Minimal / (R) Rear Fender, Molding - Scratch &amp; Dent - Minimal / Rear Bumper, Lamps, Panels - Scratch &amp; Dent - Medium / Trunk Hood, Rear Gate - Scratch &amp; Dent - Small / (L) Rear Fender, Molding - Scratch - Small / (L) Rear Door, Molding - Scratch &amp; Dent - Minimal / (L) Front Door, Molding - Scratch &amp; Dent - Minimal / (L) Step, In-panel, Side Spoiler - Scratch - Minimal / Roof - Scratch - Large / (L) Front Fender, Molding - Scratch - Large / Front Bumper, Grille, Lamps - Scratch - Large / Bonnet, Headlight - Scratch - Minimal / (R) Mirror - Scratch - Minimal / (L) Mirror - Scratch - Minimal</p> |

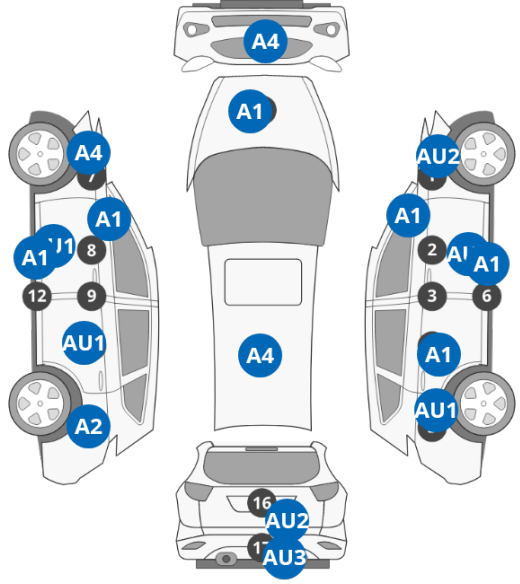
| Inspector Notes |
|---|
| With Lto plate, with spare tire and jack, 1key, no warranty booklet and tools, scratches on headlights and taillights, |
