## General Information

| Make | Toyota | Model | Vios |
| Registration No. | NIM9678 | Chassis No. | PA1B18F32P4211892 |

## Body / Panel Condition

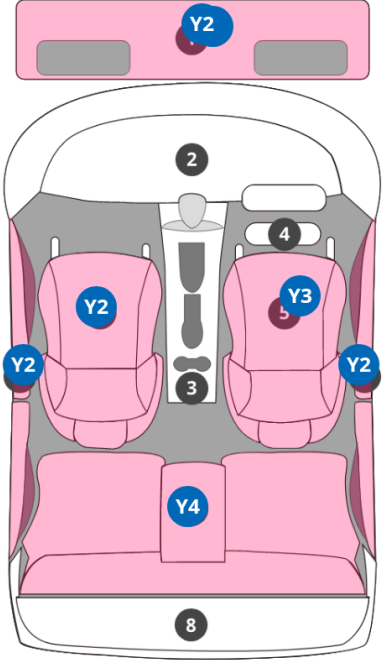
| Interior Evaluation : <b>C</b> | Exterior Evaluation : <b>E</b> |
| <b>Remarks</b><br>(L) Front Trim - Grime - Small / (R) Front Trim - Grime - Small / (R) Front Seat - Grime - Medium / (L) Front Seat - Grime - Small / Rear Seat - Grime - Large / Overall Interior - Animal Hair - Yes / Ceiling - Grime - Small | <b>Remarks</b><br>(L) Rear Fender - Repair Traces - Yes / (R) Rear Door - Repair Traces - Yes / (R) Front Fender, Molding - Crack, Gap - Medium / (R) Front Door, Molding - Scratch - Medium / Overall Exterior - Full Re-Paint in same color - Yes / (R) Rear Door, Molding - Scratch - Medium / (R) Rear Fender, Molding - Scratch - Minimal / (L) Front Fender, Molding - Scratch - Medium / (L) Front Door, Molding - Scratch - Medium / (L) Rear Door, Molding - Scratch - Small / (L) Step, In-panel, Side Spoiler - Scratch - Small / (L) Rear Fender, Molding - Scratch - Minimal / Front Bumper, Grille, Lamps - Scratch - Large / Bonnet, Headlight - Scratch - Small / Trunk Hood, Rear Gate - Scratch - Minimal / Rear Bumper, Lamps, Panels - Scratch - Medium |
