## General Information

| Make | Toyota | Model | Yaris Cross |
| Registration No. | DNW1575 | Chassis No. | MHFAB8BF3P0010177 |

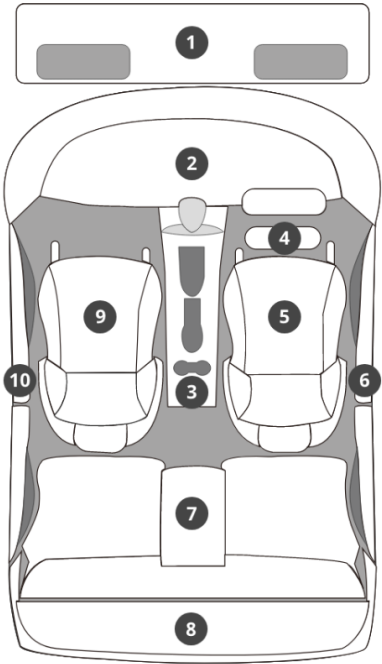
| <b>Remarks</b><br>(L) Front Floor Mat - Worked - Small / (L) Front Seat - Worn - Yes / (R) Front Seat - Grime - Small / Room Mirror - Partially Missing - Yes | | <b>Remarks</b><br>Defects not found | |
