## General Information

| Make | Mitsubishi | Model | Mirage |
| YOM | 2023 | Odo Meter Reading | 48,616 |

## Body / Panel Condition

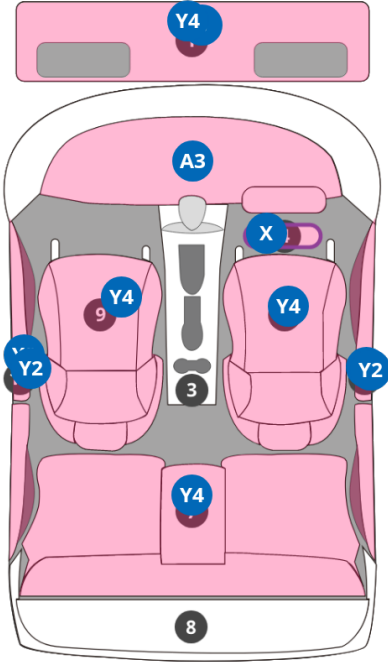
| Interior Evaluation : <b>D</b> | Exterior Evaluation : <b>E</b> |
| <p><b>Remarks</b></p> <p>Overall Interior - Smell - Yes / Ceiling - Grime - Large / (R) Front Floor Mat - Missing - Yes / Dashboard - Worn, Scratch, Cut, Crack - Medium / (R) Front Seat - Grime - Large / (L) Front Seat - Grime - Large / Rear Seat - Grime - Large / (L) Front Trim - Grime - Small / (R) Front Trim - Grime - Small / (L) Rear Trim - Grime - Small / (R) Rear Trim - Grime - Small</p> | <p><b>Remarks</b></p> <p>(R) Front Door - Repair Traces - Yes / (R) Front Fender - Repair Traces - Yes / Bonnet - Repair Traces - Yes / (L) Front Fender - Repair Traces - Yes / (L) Front Door - Repair Traces - Yes / (R) Front Fender, Molding - Partially Missing - Yes / (R) Front Fender, Molding - Repair mark - Difference in Color / (R) Front Fender, Molding - Rust, Corrosion - Large / (R) Front Door, Molding - Scratch - Medium / (R) Rear Door, Molding - Scratch &amp; Dent - Medium / (R) Rear Fender, Molding - Scratch - Small / (L) Front Fender, Molding - Repair mark - Difference in Color / (L) Front Fender, Molding - Rust, Corrosion - Large / (L) Mirror - Scratch - Small / (L) Front Door, Molding - Scratch - Large / (L) Rear Door, Molding - Scratch - Medium / (L) Rear Fender, Molding - Partially Missing - Yes / Front Bumper, Grille, Lamps - Repair mark - Difference in Color / Front Bumper, Grille, Lamps - Crack, Gap - Large / Bonnet, Headlight - Repair mark - Difference in Color / Bonnet, Headlight - Rust, Corrosion - Large / Front Windshield - Damaged - Large / Trunk Hood, Rear Gate - Scratch - Small / Rear Bumper, Lamps, Panels - Scratch &amp; Dent - Large</p> |
