## General Information

| Make | Mitsubishi | Model | Mirage |
| Registration No. | NFT8665 | Chassis No. | PAEA13TJCCA013052 |

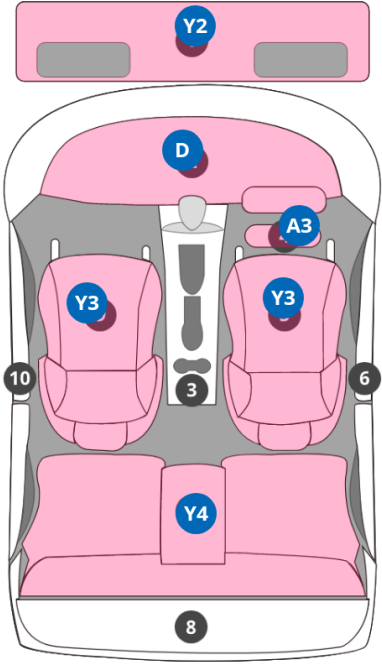
| Interior Evaluation : <b>C</b> | Exterior Evaluation : <b>E</b> |
|---|---|
| <b>Remarks</b><br>(L) Front Seat - Grime - Medium / (L) Front Floor Mat - Cut, Crack - Medium / Rear Seat - Grime - Large / (R) Front Seat - Grime - Medium / Dashboard - Traces of Adhesive Tape - Yes / Ceiling - Grime - Small | <b>Remarks</b><br>(R) Front Fender - Repair Traces - Yes / Bonnet - Repair Traces - Yes / Trunk Hood, Rear Gate - Repair Traces - Yes / (L) Rear Fender, Molding - Repair mark - Yes / (L) Rear Fender, Molding - Dent - Small / Roof - Dent - Medium / (L) Rear Door, Molding - Scratch & Dent - Small / (L) Front Door, Molding - Scratch & Dent - Minimal / Front Bumper, Grille, Lamps - Crack, Gap - Medium / (R) Front Fender, Molding - Crack, Gap - Medium / (R) Mirror - Scratch - Small / Bonnet, Headlight - Scratch - Small / (R) Step, In-panel, Side Spoiler - Scratch & Dent - Large / (R) Front Door, Molding - Scratch & Dent - Minimal / (R) Rear Fender, Molding - Repair mark - Yes / (R) Rear Door, Molding - Scratch - Small / Rear Bumper, Lamps, Panels - Scratch & Dent - Medium / Trunk Hood, Rear Gate - Repair mark - Yes / Trunk Hood, Rear Gate - Scratch - Small / (R) Rear Fender, Molding - Scratch - Small |
