## General Information

| Make | Mitsubishi | Model | Mirage |
| YOM | 2018 | Odo Meter Reading | 81,751 |
| Registration No. | NDP3356 | Chassis No. | PAEA13TJJJA006338 |

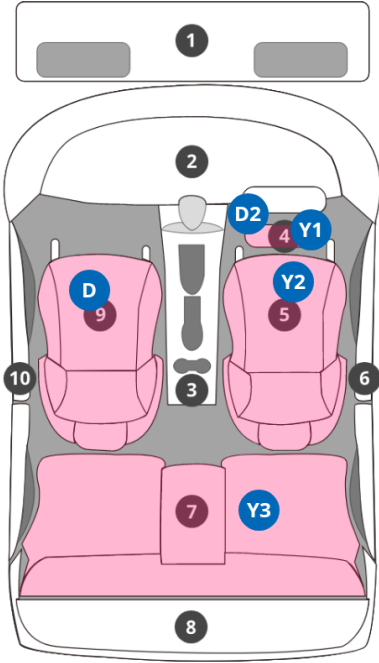
| Interior Evaluation : <span style="color: red;">C</span> | Exterior Evaluation : <span style="color: red;">D</span> |
|---|---|
| <p><b>Remarks</b><br/>Rear Seat - Grime - Medium / (R) Front Seat - Grime - Small / (R) Front Floor Mat - Grime - Minimal / (L) Front Floor Mat - Worked - Small / (L) Front Seat - Worn - Yes / Overall Interior - Worn as per age - Yes</p> | <p><b>Remarks</b><br/>(L) Front Fender - Repair Traces - Yes / (L) Front Fender, Molding - Repair mark - Yes / (L) Front Door, Molding - Repair mark - Yes / (L) Front Fender, Molding - Scratch - Small / (L) Front Door, Molding - Scratch &amp; Dent - Minimal / (L) Step, In-panel, Side Spoiler - Scratch - Small / (L) Rear Door, Molding - Scratch - Small / (L) Rear Fender, Molding - Scratch - Small / (L) Rear Fender, Molding - Repair mark - Yes / Trunk Hood, Rear Gate - Scratch &amp; Dent - Small / Rear Bumper, Lamps, Panels - Scratch - Small / (R) Rear Fender, Molding - Scratch - Small / (R) Rear Door, Molding - Scratch - Small / (R) Step, In-panel, Side Spoiler - Scratch - Small / (R) Front Door, Molding - Scratch - Small / (R) Mirror - Scratch - Minimal / (R) Front Fender, Molding - Scratch - Small / Front Bumper, Grille, Lamps - Scratch - Medium / Bonnet, Headlight - Scratch - Minimal / Roof - Scratch - Small / Overall Exterior - Worn as per age - Yes</p> |
