## General Information

| Make | Nissan | Model | NV350 |
| Registration No. | NCM4520 | Chassis No. | JN1TC2E26Z0016891 |

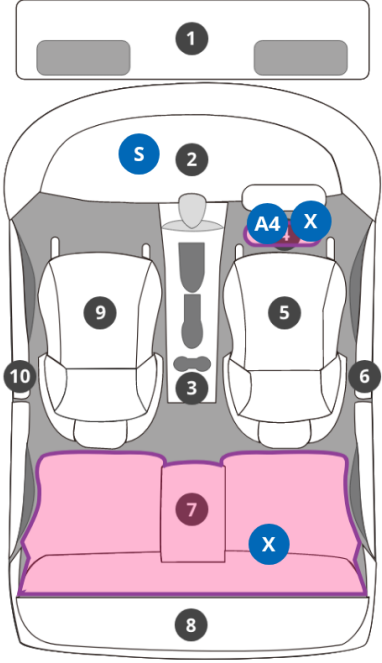
| Interior Evaluation : <span style="color: red;">C</span> | Exterior Evaluation : <span style="color: red;">E</span> |
| <p><b>Remarks</b></p> <p>Overall Interior - Worn as per age - Yes / Overall Interior - Smell - Yes / Mat Other - Missing - Yes / Rear Seat - Partially Missing - Yes / Carpet - Worn, Scratch, Cut, Crack - Large</p> | <p><b>Remarks</b></p> <p>Trunk Hood, Rear Gate - Repair Traces - Yes / (L) Rear Fender, Molding - Scratch &amp; Dent - Large / (L) Rear Fender, Molding - Repair mark - Yes / Trunk Hood, Rear Gate - Scratch &amp; Dent - Large / Trunk Hood, Rear Gate - Repair mark - Yes / Rear Bumper, Lamps, Panels - Scratch &amp; Dent - Large / (R) Rear Fender, Molding - Scratch &amp; Dent - Large / (R) Rear Door, Molding - Scratch &amp; Dent - Large / (R) Center Panel - Scratch - Medium / (R) Front Door, Molding - Repair mark - Yes / (R) Front Door, Molding - Scratch - Large / Front Bumper, Grille, Lamps - Scratch &amp; Dent - Large / Front Panel - Scratch &amp; Dent - Small / (L) Front Door, Molding - Scratch - Small / Roof - Scratch &amp; Dent - Medium</p> |
