## General Information

| Make | Nissan | Model | Almera |
| YOM | 2020 | Odo Meter Reading | 60,726 |
| Registration No. | NAN2775 | Chassis No. | BDUALBAN17C52252 |

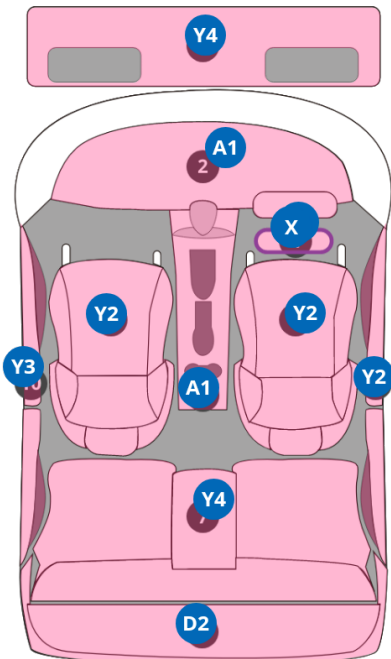
| Interior Evaluation : <div>C</div> | | Exterior Evaluation : <div>E</div> | |
|---|--|---|--|
| <div>Remarks</div> <div>Ceiling - Grime - Large / (L) Front Trim - Grime - Medium / (R) Front Trim - Grime - Small / (R) Front Floor Mat - Missing - Yes / (L) Front Floor Mat - Missing - Yes / Mat Other - Missing - Yes / (R) Front Seat - Grime - Small / (L) Front Seat - Grime - Small / Dashboard - Worn, Scratch, Cut, Crack - Minimal / Console, Switches, Vents - Worn, Scratch, Cut, Crack - Minimal / Rear Seat - Grime - Large / Trunk Room - Loose, Deformed - Small</div> | | <div>Remarks</div> <div>(R) Front Door - Repair Traces - Yes / (R) Step - Repair Traces - Yes / (R) Front Fender - Repair Traces - Yes / Bonnet - Repair Traces - Yes / (L) Front Fender - Repair Traces - Yes / (L) Front Door - Repair Traces - Yes / (L) Rear Door - Repair Traces - Yes / (L) Rear Fender - Repair Traces - Yes / Trunk Hood, Rear Gate - Repair Traces - Yes / (R) Rear Fender - Repair Traces - Yes / (R) Rear Door - Repair Traces - Yes / Roof - Repair Traces - Yes / (R) Front Fender, Molding - Dent - Large / (R) Front Door, Molding - Scratch &amp; Dent - Large / (R) Step, In-panel, Side Spoiler - Scratch &amp; Dent - Large / (R) Rear Door, Molding - Scratch &amp; Dent - Large / (R) Rear Fender, Molding - Scratch - Medium / Overall Exterior - Faded(Color, Gloss) - Yes / (L) Front Fender, Molding - Repair mark - Difference in Color / (L) Front Fender, Molding - Scratch &amp; Dent - Large / (L) Front Door, Molding - Repair mark - Difference in Color / (L) Front Door, Molding - Scratch &amp; Dent - Large / (L) Rear Door, Molding - Repair mark - Difference in Color / (L) Rear Door, Molding - Rust, Corrosion - Large / (L) Step, In-panel, Side Spoiler - Scratch &amp; Dent - Medium / (L) Rear Fender, Molding - Repair mark - Difference in Color / (L) Rear Fender, Molding - Scratch &amp; Dent - Large / Front Bumper, Grille, Lamps - Repair mark - Difference in Color / Front Bumper, Grille, Lamps - Crack, Gap - Large / Bonnet, Headlight - Rust, Corrosion - Medium / Antennae - Damaged - Yes / Trunk Hood, Rear Gate - Rust, Corrosion - Medium / Rear Bumper, Lamps, Panels - Repair mark - Difference in Color / Rear Bumper, Lamps, Panels - Scratch &amp; Dent - Large</div> | |

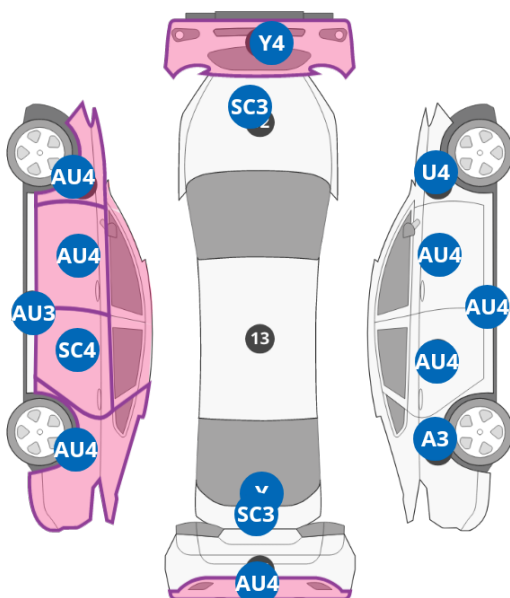
With LTO plate, no warranty booklet, no tools, no jack, no spare key, with seat cover, no reverse camera, with spare rim but separated to the tire, damaged rear and front bumpers, with repaired parts difference in color, air-condition weak, color faded, no floor mat, missing antenna.
