## General Information

| Make | Toyota | Model | Vios |
| Registration No. | CBE8177 | Chassis No. | PA1B18F32N4197229 |

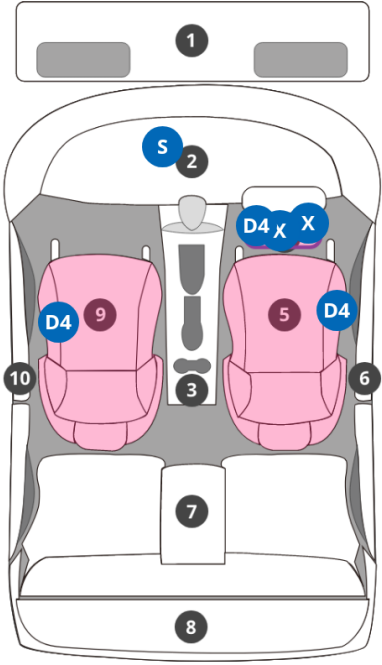
| Interior Evaluation : <span style="color: red;">C</span> | Exterior Evaluation : <span style="color: red;">E</span> |
| <b>Remarks</b><br>(R) Front Floor Mat - Missing - Yes / Mat Other - Missing - Yes / (L) Front Floor Mat - Worked - Large / Overall Interior - Smell - Yes / (R) Front Seat belt - Loose, Deformed - Large / (L) Front Seat belt - Loose, Deformed - Large | <b>Remarks</b><br>Bonnet - Repair Traces - Yes / (L) Front Fender - Repair Traces - Yes / (L) Front Door - Repair Traces - Yes / (L) Step - Repair Traces - Yes / (L) Rear Door - Repair Traces - Yes / (L) Rear Fender - Repair Traces - Yes / Trunk Hood, Rear Gate - Repair Traces - Yes / Front Bumper, Grille, Lamps - Scratch & Dent - Large / (L) Rear Door, Molding - Dent - Large / (L) Step, In-panel, Side Spoiler - Dent - Large / (L) Front Door, Molding - Dent - Small / (L) Rear Fender, Molding - Scratch - Medium / Rear Bumper, Lamps, Panels - Scratch & Dent - Large / (R) Rear Fender, Molding - Scratch - Large / Rear Bumper, Lamps, Panels - Repair mark - Yes / Front Bumper, Grille, Lamps - Repair mark - Yes / (R) Front Door, Molding - Dent - Small / (R) Front Fender, Molding - Partially Missing - Yes / Bonnet, Headlight - Repair mark - Yes |
