## General Information

| Make | Suzuki | Model | APV |
| Registration No. | NKD7541 | Chassis No. | MHYDN71V7RJ402025 |

## Body / Panel Condition

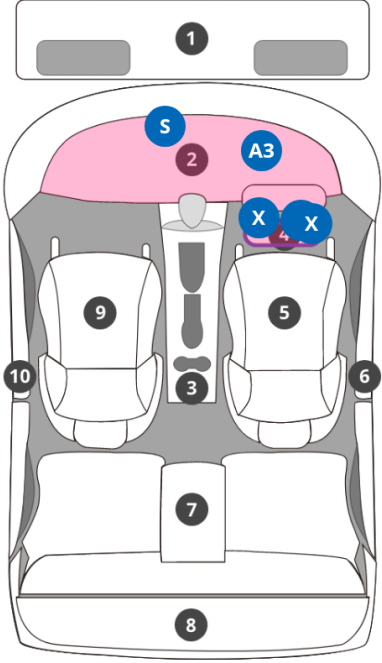
| Interior Evaluation : <b>B</b> | Exterior Evaluation : <b>D</b> |
| <p><b>Remarks</b></p> <p>(R) Front Floor Mat - Missing - Yes / (L) Front Floor Mat - Missing - Yes / Mat Other - Missing - Yes / Overall Interior - Smell - Yes / Dashboard - Worn, Scratch, Cut, Crack - Medium</p> | <p><b>Remarks</b></p> <p>(R) Front Door, Molding - Scratch &amp; Dent - Large / Rear Bumper, Lamps, Panels - Scratch &amp; Dent - Large / (L) Rear Door, Molding - Scratch &amp; Dent - Large / Trunk Hood, Rear Gate - Scratch &amp; Dent - Medium / Front Bumper, Grille, Lamps - Scratch &amp; Dent - Large / Roof - Dent - Small / (R) Rear Door, Molding - Scratch - Small / (L) Front Door, Molding - Dent - Small / (R) Rear Fender, Molding - Scratch - Minimal / (L) Rear Fender, Molding - Scratch - Small</p> |
