## General Information

| Make | Toyota | Model | Hilux Tamaraw |
| YOM | 2025 | Odo Meter Reading | 13,838 |
| Registration No. | NKP5144 | Chassis No. | PAHACACA9S6422313 |

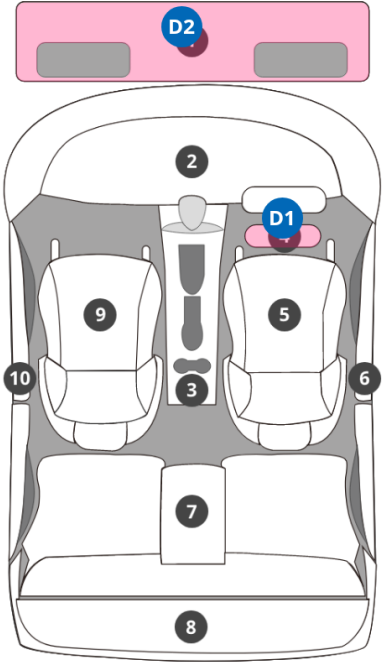
| Interior Evaluation : <span style="color: red;">A</span> | Exterior Evaluation : <span style="color: red;">C</span> |
| <b>Remarks</b><br>Carpet - Worked - Minimal / Ceiling - Loose, Deformed - Small | <b>Remarks</b><br>(R) Front Fender, Molding - Scratch - Minimal / (R) Mirror - Scratch - Minimal / (R) Front Door, Molding - Scratch - Minimal / (R) Side Gate - Scratch & Dent - Medium / Cargo Bed Floor - Scratch - Large / Rear Gate - Scratch - Minimal / (L) Side Gate - Scratch & Dent - Large / (L) Front Door, Molding - Scratch - Medium / (L) Mirror - Crack - Damaged / Roof - Dent - Minimal / Front Bumper, Grille, Lamps - Scratch - Minimal |
