## General Information

| Make | Toyota | Model | Avanza |
| Registration No. | GBA5265 | Chassis No. | MHFAA1BYXP0017588 |

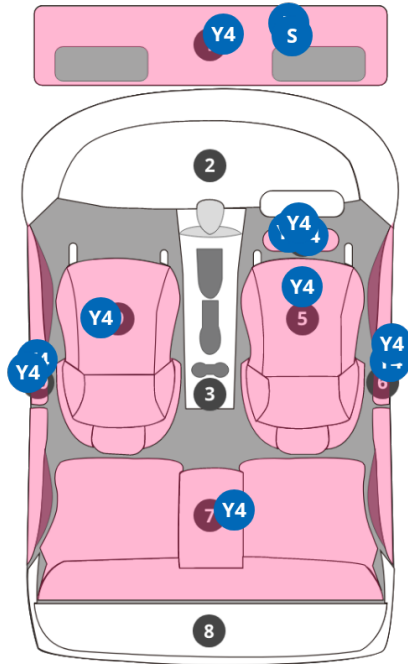
| Interior Evaluation : | | E | Exterior Evaluation : | | N / A | |
|---|--|---|---|---|---|---|
| <div></div> <p>a : Cut, Fray d : Loose, Deformed k : Animal Hair s : Smell t : Cigarette Burns x : Defective y : Stain</p> | | | | | | |
| <b>Remarks</b><br>Ceiling - Grime - Large / (R) Front Seat - Grime - Large / (R) Front Floor Mat - Grime - Large / (L) Front Floor Mat - Grime - Large / Mat Other - Grime - Large / (L) Front Seat - Grime - Large / (R) Rear Trim - Grime - Large / (R) Front Trim - Grime - Large / Rear Seat - Grime - Large / (L) Front Trim - Grime - Large / (L) Rear Trim - Grime - Large / Overall Interior - Animal Hair - Yes / Overall Interior - Smell - Yes | | | <b>Remarks</b><br>Defects not found | | | |
