## General Information

Date & Time: 15, Jul, 2026 15:41

| Make | Toyota | Model | Avanza |
| Registration No. | DCE5725 | Chassis No. | MHFAA1BY5S0055738 |

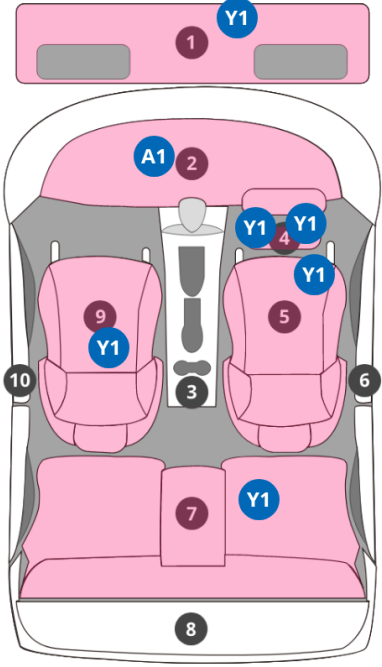
| Interior Evaluation : <span style="color: red; font-weight: bold;">A</span> | Exterior Evaluation : <span style="color: red; font-weight: bold;">D</span> |
| <b>Remarks</b><br>Dashboard - Worn, Scratch, Cut, Crack - Minimal / (L)<br>Front Floor Mat - Grime - Minimal / (R) Front Floor Mat - Grime - Minimal / Rear Seat - Grime - Minimal / (L)<br>Front Seat - Grime - Minimal / (R) Front Seat - Grime - Minimal / Ceiling - Grime - Minimal | <b>Remarks</b><br>(R) Front Fender, Molding - Dent - Large / (R) Front Door, Molding - Crack, Gap - Large / (R) Rear Door, Molding - Scratch - Minimal / (R) Step, In-panel, Side Spoiler - Scratch - Minimal / (R) Rear Fender, Molding - Scratch - Minimal / Rear Bumper, Lamps, Panels - Scratch - Minimal / Trunk Hood, Rear Gate - Scratch - Minimal / (L) Rear Fender, Molding - Scratch - Minimal / (L) Step, In-panel, Side Spoiler - Scratch - Minimal / (L) Rear Door, Molding - Scratch - Minimal / (L) Front Door, Molding - Scratch - Minimal / (L) Front Fender, Molding - Scratch - Minimal / Front Bumper, Grille, Lamps - Crack, Gap - Medium / Bonnet, Headlight - Crack, Gap - Medium / Roof - Rust, Corrosion - Medium |

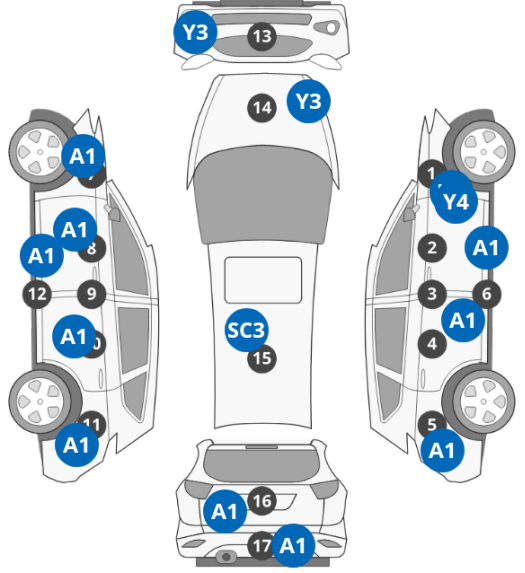
| Inspector Notes |
|---|
| with Ito plate/with warranty booklet/with spare tire/with spare key/with hairlines scratches on the body/with reverse camera/unusual noise while opening front passenger door/dent in right side headlight bracket |
