## General Information

| Make | Toyota | Model | Avanza |
| YOM | 2025 | Odo Meter Reading | 17,211 |
| Registration No. | NLA7123 | Chassis No. | MHFAA1BY3S0047895 |

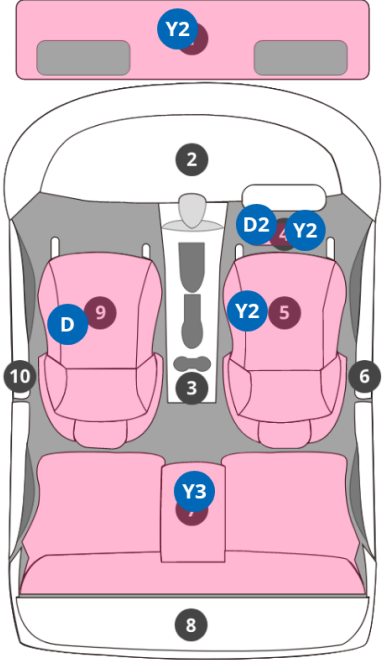
| Interior Evaluation : <b>B</b> | Exterior Evaluation : <b>D</b> |
| <p><b>Remarks</b></p> <p>Rear Seat - Grime - Medium / (R) Front Seat - Grime - Small / (R) Front Floor Mat - Grime - Small / (L) Front Floor Mat - Worked - Small / (L) Front Seat - Worn - Yes / Ceiling - Grime - Small</p> | <p><b>Remarks</b></p> <p>(L) Front Fender - Repair Traces - Yes / (L) Front Fender, Molding - Repair mark - Yes / (L) Front Fender, Molding - Scratch - Minimal / (L) Step, In-panel, Side Spoiler - Scratch &amp; Dent - Large / (L) Front Door, Molding - Scratch - Minimal / (L) Rear Door, Molding - Scratch &amp; Dent - Medium / (L) Rear Fender, Molding - Scratch &amp; Dent - Small / Trunk Hood, Rear Gate - Scratch - Minimal / Rear Bumper, Lamps, Panels - Scratch - Minimal / (R) Rear Fender, Molding - Scratch &amp; Dent - Small / (R) Rear Door, Molding - Scratch &amp; Dent - Large / (R) Front Door, Molding - Scratch - Small / (R) Step, In-panel, Side Spoiler - Scratch - Minimal / (R) Front Fender, Molding - Scratch - Minimal / Front Bumper, Grille, Lamps - Repair mark - Yes / Front Bumper, Grille, Lamps - Scratch - Small / Bonnet, Headlight - Scratch - Minimal / Roof - Scratch - Minimal</p> |
