## General Information

| Make | Toyota | Model | Avanza |
| Registration No. | NJA9956 | Chassis No. | MHFAA1BY7S0039542 |

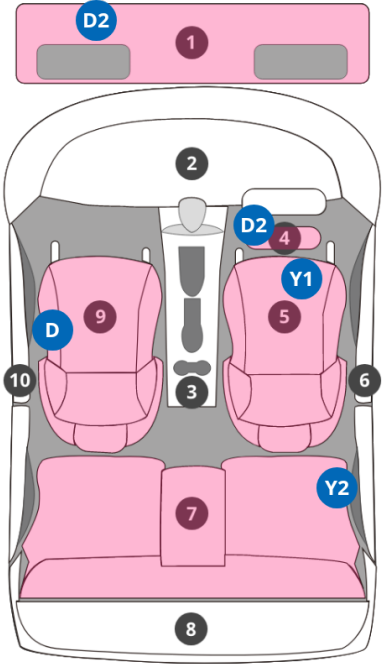
| <b>Remarks</b><br>(L) Front Seat - Worn - Yes / (L) Front Floor Mat - Worked - Small / Ceiling - Crinkle - Small / (R) Front Seat - Grime - Minimal / Rear Seat - Grime - Small | <b>Remarks</b><br>(R) Front Door - Repair Traces - Yes / (R) Front Fender - Repair Traces - Yes / Bonnet - Repair Traces - Yes / (R) Front Fender, Molding - Dent - Large / (R) Mirror - Scratch - Small / (R) Front Door, Molding - Scratch - Large / (R) Rear Door, Molding - Scratch - Large / (R) Rear Fender, Molding - Scratch - Large / (R) Step, In-panel, Side Spoiler - Scratch & Dent - Small / Trunk Hood, Rear Gate - Scratch - Minimal / Rear Bumper, Lamps, Panels - Scratch - Medium / (L) Rear Fender, Molding - Scratch - Small / (L) Step, In-panel, Side Spoiler - Scratch & Dent - Small / (L) Rear Door, Molding - Scratch - Small / (L) Front Door, Molding - Scratch - Small / (L) Mirror - Scratch - Small / (L) Front Fender, Molding - Scratch - Small / Front Bumper, Grille, Lamps - Modified - Medium / Front Bumper, Grille, Lamps - Crack, Gap - Medium / Bonnet, Headlight - Crack, Gap - Large / Front Windshield - Damaged - Large / Roof - Dent - Small |
