## General Information

| Make | Toyota | Model | Avanza |
| YOM | 2023 | Odo Meter Reading | 73,419 |
| Registration No. | DBH7105 | Chassis No. | MHFAA1BYXP0013962 |

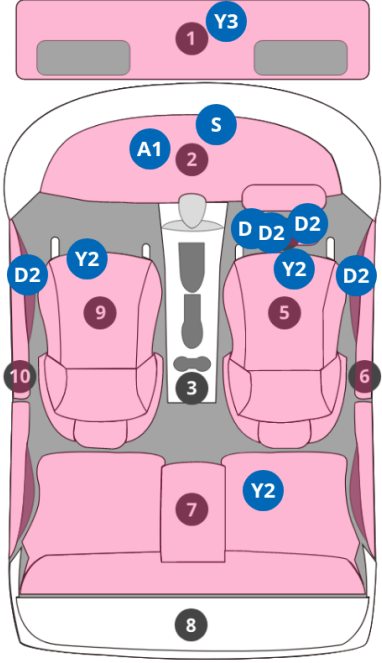
| Interior Evaluation : <b>C</b> | Exterior Evaluation : <b>E</b> |
| <p><b>Remarks</b></p> <p>Overall Interior - Smell - Yes / Rear Seat - Grime - Small / (L) Front Seat - Grime - Small / (R) Front Seat - Grime - Small / (L) Front Floor Mat - Worked - Small / (R) Front Floor Mat - Worked - Small / Mat Other - Worked - Small / Dashboard - Worn, Scratch, Cut, Crack - Minimal / Ceiling - Grime - Medium / (L) Front Trim - Worked - Small / (R) Front Trim - Worked - Small</p> | <p><b>Remarks</b></p> <p>Bonnet - Repair Traces - Yes / (R) Front Fender, Molding - Scratch - Minimal / (R) Mirror - Scratch - Minimal / (R) Front Door, Molding - Scratch - Minimal / (R) Step, In-panel, Side Spoiler - Scratch - Small / (R) Rear Door, Molding - Scratch - Medium / (R) Rear Fender, Molding - Scratch &amp; Dent - Medium / Trunk Hood, Rear Gate - Scratch &amp; Dent - Medium / Rear Bumper, Lamps, Panels - Scratch &amp; Dent - Large / (L) Rear Fender, Molding - Scratch &amp; Dent - Medium / (L) Rear Door, Molding - Scratch &amp; Dent - Medium / (L) Step, In-panel, Side Spoiler - Scratch - Small / (L) Front Door, Molding - Scratch &amp; Dent - Small / (L) Front Fender, Molding - Scratch - Medium / Front Bumper, Grille, Lamps - Scratch - Large / Bonnet, Headlight - Scratch - Small / Roof - Scratch - Minimal / (L) Mirror - Scratch - Minimal</p> |

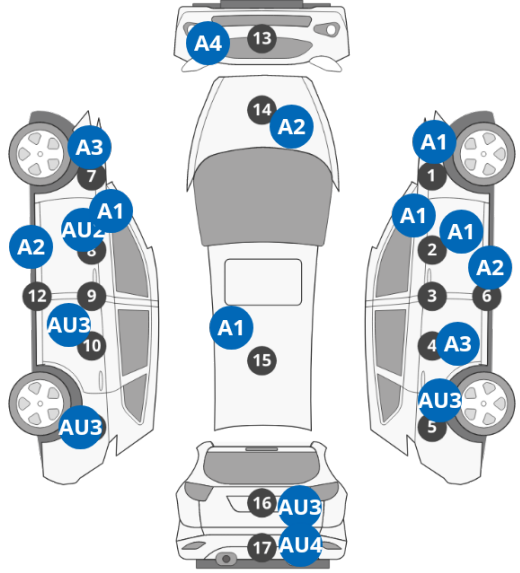
| Inspector Notes |
|---|
| with Ito plate/without warranty booklet/with spare tire/with dent and hairlines scratches on the body/with reverse camera/with rust on rear door/with plate light issue/with dome light issue/possible flooded/key remote buttons issue/glovebox missing |
