## General Information

| Make | Toyota | Model | Innova |
| Registration No. | NFR7324 | Chassis No. | PA2JA8EM9R0141464 |

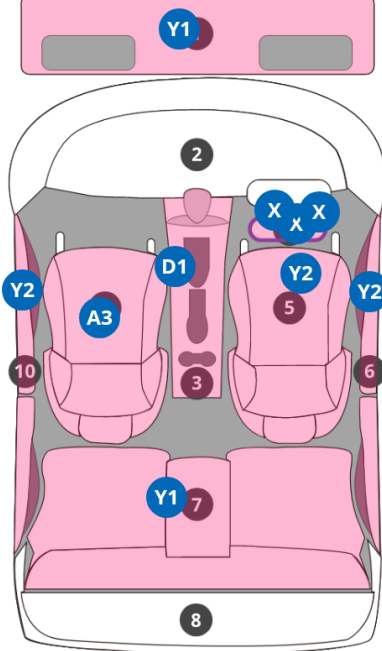
| Interior Evaluation : <b>B</b> | Exterior Evaluation : <b>E</b> |
| <p><b>Remarks</b></p> <p>(L) Front Seat - Cut, Crack - Medium / (R) Front Seat - Grime - Small / (L) Front Floor Mat - Missing - Yes / (R) Front Floor Mat - Missing - Yes / Mat Other - Missing - Yes / Rear Seat - Grime - Minimal / (L) Front Trim - Grime - Small / (R) Front Trim - Grime - Small / Ceiling - Grime - Minimal / Console, Switchs, Vents - Worked - Minimal</p> | <p><b>Remarks</b></p> <p>(R) Front Fender - Repair Traces - Yes / Bonnet - Repair Traces - Yes / (L) Front Fender - Repair Traces - Yes / Trunk Hood, Rear Gate - Repair Traces - Yes / Roof - Scratch - Small / (R) Front Door, Molding - Scratch &amp; Dent - Large / (R) Rear Door, Molding - Scratch &amp; Dent - Medium / (R) Rear Door, Molding - Repair mark - Yes / (R) Rear Fender, Molding - Repair mark - Yes / (R) Rear Fender, Molding - Scratch &amp; Dent - Medium / Rear Bumper, Lamps, Panels - Repair mark - Yes / Trunk Hood, Rear Gate - Repair mark - Yes / Trunk Hood, Rear Gate - Scratch &amp; Dent - Small / Rear Bumper, Lamps, Panels - Scratch &amp; Dent - Medium / (L) Rear Fender, Molding - Scratch &amp; Dent - Medium / (L) Rear Door, Molding - Scratch &amp; Dent - Minimal / (L) Front Door, Molding - Scratch &amp; Dent - Small / (L) Step, In-panel, Side Spoiler - Scratch &amp; Dent - Minimal / (L) Front Fender, Molding - Scratch &amp; Dent - Small / Bonnet, Headlight - Scratch &amp; Dent - Small / Front Bumper, Grille, Lamps - Scratch - Small / (R) Front Fender, Molding - Scratch &amp; Dent - Small</p> |

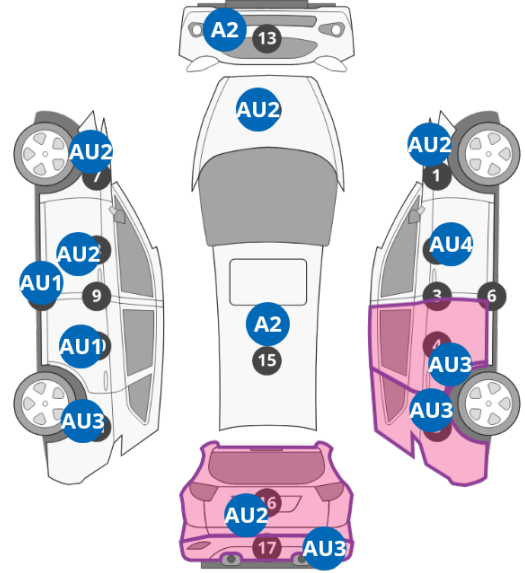
| Inspector Notes |
|---|
| with LTO plate, with spare tire and key, with reverse camera, with manual and warranty booklet, no tools and jack, scratches and dent on exterior, scratches in taillight and headlight. |
