## General Information

| Make | Toyota | Model | Lite Ace |
| Registration No. | NHJ8027 | Chassis No. | MHKU3FE10PK004001 |

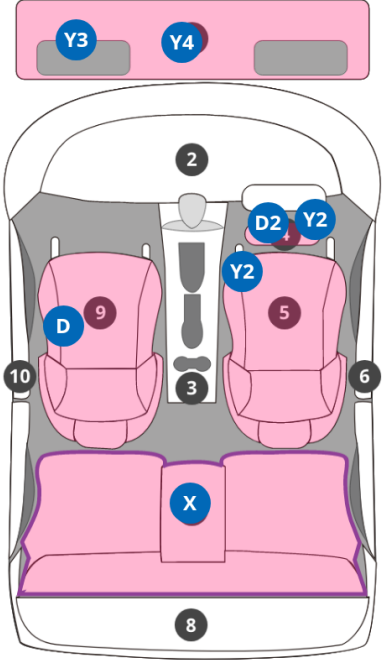
| Interior Evaluation : <b>C</b> | Exterior Evaluation : <b>E</b> |
| <p><b>Remarks</b></p> <p>Rear Seat - Missing - Yes / (R) Front Seat - Grime - Small / (R) Front Floor Mat - Grime - Small / (L) Front Seat - Worn - Yes / (L) Front Floor Mat - Worked - Small / Ceiling - Grime - Large / Sunvisor, Sunglass Holder - Grime - Medium</p> | <p><b>Remarks</b></p> <p>(R) Front Door - Repair Traces - Yes / Front Panel - Repair Traces - Yes / (L) Front Door - Repair Traces - Yes / (L) Rear Corner Panel - Repair Traces - Yes / (R) Rear Corner Panel - Repair Traces - Yes / Roof - Repair Traces - Yes / (R) Side Gate - Repair mark - Yes / (L) Side Gate - Repair mark - Yes / (R) Side Gate - Scratch &amp; Dent - Large / (R) Center Panel - Scratch - Small / (R) Front Door, Molding - Scratch &amp; Dent - Large / (R) Step, In-panel, Side Spoiler - Scratch - Small / (R) Mirror - Scratch - Minimal / (R) Front Fender, Molding - Scratch - Small / Front Bumper, Grille, Lamps - Scratch &amp; Dent - Large / Front Panel - Scratch &amp; Dent - Medium / (L) Front Fender, Molding - Scratch - Small / (L) Front Door, Molding - Scratch - Medium / (L) Center Panel - Scratch - Small / (L) Step, In-panel, Side Spoiler - Scratch - Small / (L) Side Gate - Scratch &amp; Dent - Large / Rear Bumper, Lamps, Panels - Rust, Corrosion - Medium / Cargo Bed Floor - Scratch - Large / Rear Gate - Scratch &amp; Dent - Medium / Roof - Scratch &amp; Dent - Large</p> |
