## General Information

| Make | Toyota | Model | Vios |
| Registration No. | DBR5320 | Chassis No. | PA1B18F37R4276448 |

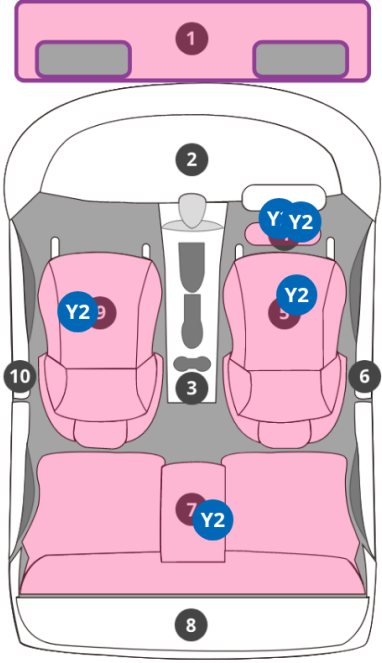
| Interior Evaluation : <b>B</b> | Exterior Evaluation : <b>D</b> |
|---|---|
| <p><b>Remarks</b></p> <p>(L) Front Floor Mat - Grime - Small / (R) Front Floor Mat - Grime - Small / (L) Front Seat - Grime - Small / (R) Front Seat - Grime - Small / Rear Seat - Grime - Small / Room Lamp - Missing - Yes</p> | <p><b>Remarks</b></p> <p>(R) Front Fender - Repair Traces - Yes / Bonnet - Repair Traces - Yes / (L) Front Fender - Repair Traces - Yes / Trunk Hood, Rear Gate - Repair Traces - Yes / (R) Rear Fender - Repair Traces - Yes / (R) Rear Fender - Replaced - Yes / (R) Rear Fender, Molding - Repair mark - Yes / Trunk Hood, Rear Gate - Repair mark - Yes / Trunk Hood, Rear Gate - Scratch - Medium / Rear Bumper, Lamps, Panels - Repair mark - Yes / (R) Rear Fender, Molding - Scratch &amp; Dent - Small / (R) Rear Door, Molding - Scratch &amp; Dent - Small / (R) Front Door, Molding - Scratch &amp; Dent - Small / (R) Step, In-panel, Side Spoiler - Scratch &amp; Dent - Small / Roof - Scratch &amp; Dent - Small / (R) Front Fender, Molding - Scratch &amp; Dent - Small / Bonnet, Headlight - Scratch &amp; Dent - Small / Front Bumper, Grille, Lamps - Scratch - Small / (L) Front Fender, Molding - Scratch &amp; Dent - Small / (L) Front Door, Molding - Scratch &amp; Dent - Small / (L) Rear Door, Molding - Scratch &amp; Dent - Small / (L) Rear Fender, Molding - Scratch &amp; Dent - Medium / (L) Step, In-panel, Side Spoiler - Scratch &amp; Dent - Minimal</p> |
