## General Information

| Make | Mitsubishi | Model | Mirage |
| Registration No. | LAO5122 | Chassis No. | PAEA03RGRRRA008082 |

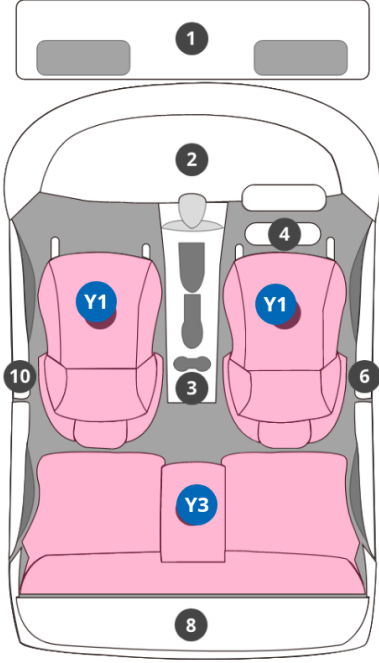
| Interior Evaluation : <b>B</b> | Exterior Evaluation : <b>D</b> |
| <b>Remarks</b><br>(R) Front Seat - Grime - Minimal / (L) Front Seat - Grime - Minimal / Rear Seat - Grime - Medium | <b>Remarks</b><br>(R) Rear Fender - Repair Traces - Yes / (R) Front Fender, Molding - Scratch - Minimal / (R) Front Door, Molding - Scratch - Small / (R) Rear Door, Molding - Rust, Corrosion - Medium / (R) Rear Fender, Molding - Repair mark - Difference in Color / (L) Front Fender, Molding - Scratch & Dent - Medium / (L) Front Door, Molding - Scratch - Medium / (L) Rear Door, Molding - Scratch - Minimal / (L) Rear Fender, Molding - Scratch - Minimal / Front Bumper, Grille, Lamps - Scratch & Dent - Large / Bonnet, Headlight - Scratch - Minimal / Trunk Hood, Rear Gate - Scratch - Minimal / Rear Bumper, Lamps, Panels - Scratch & Dent - Medium / (L) Mirror - Scratch - Small |
