## General Information

| Make | Mitsubishi Fuso | Model | Canter |
| Registration No. | DAZ4960 | Chassis No. | JL6J2B6T9KK002145 |

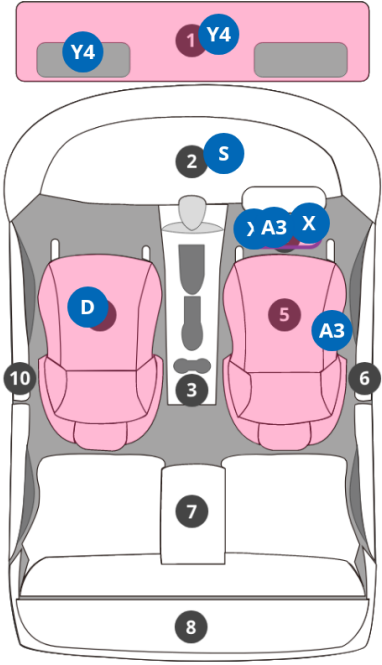
| Interior Evaluation : <span style="color: red;">C</span> | Exterior Evaluation : <span style="color: red;">E</span> |
|---|---|
| <p><b>Remarks</b></p> <p>(R) Front Seat - Cut, Crack - Medium / (L) Front Seat - Worn - Yes / (R) Front Floor Mat - Missing - Yes / (L) Front Floor Mat - Missing - Yes / Carpet - Worn, Scratch, Cut, Crack - Medium / Sunvisor, Sunglass Holder - Grime - Large / Ceiling - Grime - Large / Overall Interior - Smell - Yes</p> | <p><b>Remarks</b></p> <p>(R) Front Door - Repair Traces - Yes / Front Panel - Repair Traces - Yes / (L) Front Door - Repair Traces - Yes / (L) Rear Corner Panel - Repair Traces - Yes / (R) Rear Corner Panel - Repair Traces - Yes / Roof - Repair Traces - Yes / Cargo Bed Floor - Scratch - Large / Rear Bumper, Lamps, Panels - Rust, Corrosion - Large / Rear Gate - Modified - Medium / Rear Gate - Rust, Corrosion - Medium / (L) Side Gate - Scratch &amp; Dent - Large / (L) Front Door, Molding - Scratch - Large / (L) Mirror - Faded(Color, Gloss) - Yes / (L) Front Fender, Molding - Scratch - Minimal / Front Panel - Scratch - Small / (R) Mirror - Faded(Color, Gloss) - Yes / Front Bumper, Grille, Lamps - Scratch &amp; Dent - Medium / (R) Front Fender, Molding - Scratch - Minimal / (L) Step, In-panel, Side Spoiler - Scratch - Small / (R) Front Door, Molding - Scratch - Large / (R) Step, In-panel, Side Spoiler - Scratch - Small / (R) Side Gate - Rust, Corrosion - Large / Cab Back Panel - Scratch - Small / Roof - Scratch &amp; Dent - Small / Overall Exterior - Faded(Color, Gloss) - Yes</p> |
