## General Information

| Make | Toyota | Model | Vios |
| YOM | 2025 | Odo Meter Reading | 41,024 |
| Registration No. | ZAF6016 | Chassis No. | PA1B18F39S4283598 |

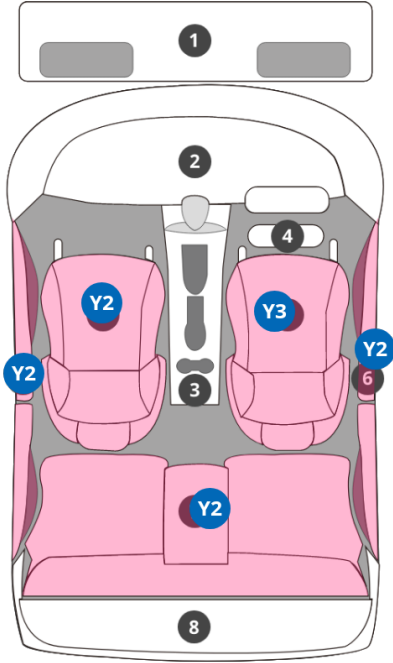
| Interior Evaluation : <b>B</b> | Exterior Evaluation : <b>E</b> |
| <b>Remarks</b><br>(R) Front Seat - Grime - Medium / (L) Front Seat - Grime - Small / (L) Front Trim - Grime - Small / (R) Front Trim - Grime - Small / Rear Seat - Grime - Small | <b>Remarks</b><br>(R) Front Door - Repair Traces - Yes / (R) Front Fender - Repair Traces - Yes / Bonnet - Repair Traces - Yes / (L) Front Fender - Repair Traces - Yes / (L) Front Door - Repair Traces - Yes / (L) Rear Door - Repair Traces - Yes / (L) Rear Fender - Repair Traces - Yes / Trunk Hood, Rear Gate - Repair Traces - Yes / (R) Rear Fender - Repair Traces - Yes / (R) Rear Door - Repair Traces - Yes / Roof - Repair Traces - Yes / (R) Front Fender, Molding - Repair mark - Difference in Color / (R) Front Fender, Molding - Scratch - Small / (R) Front Door, Molding - Scratch - Medium / (R) Rear Door, Molding - Scratch - Large / (R) Rear Fender, Molding - Scratch - Small / (R) Step, In-panel, Side Spoiler - Scratch & Dent - Large / (L) Front Fender, Molding - Crack, Gap - Medium / (L) Front Door, Molding - Scratch & Dent - Large / (L) Rear Door, Molding - Scratch - Medium / (L) Rear Fender, Molding - Scratch - Small / Front Bumper, Grille, Lamps - Scratch & Dent - Medium / Bonnet, Headlight - Scratch - Minimal / Trunk Hood, Rear Gate - Scratch - Minimal / Rear Bumper, Lamps, Panels - Crack, Gap - Small |
