## General Information

| Make | Mitsubishi | Model | Xpander |
| YOM | 2019 | Odo Meter Reading | 85,854 |
| Registration No. | NDP9291 | Chassis No. | MK2XRNC1WKN027530 |

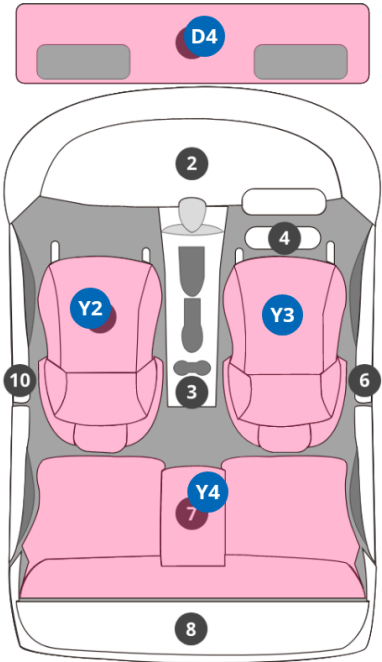
| <b>Interior Evaluation :</b> <span style="color: red; font-weight: bold;">C</span> | <b>Exterior Evaluation :</b> <span style="color: red; font-weight: bold;">E</span> |
| <b>Remarks</b><br>Ceiling - Crinkle - Large / Rear Seat - Grime - Large / (R) Front Seat - Grime - Medium / (L) Front Seat - Grime - Small | <b>Remarks</b><br>(R) Front Door - Repair Traces - Yes / (R) Step - Repair Traces - Yes / (R) Front Fender - Repair Traces - Yes / Bonnet - Repair Traces - Yes / (L) Front Fender - Repair Traces - Yes / (L) Front Door - Repair Traces - Yes / (L) Step - Repair Traces - Yes / (L) Rear Door - Repair Traces - Yes / (L) Rear Fender - Repair Traces - Yes / Trunk Hood, Rear Gate - Repair Traces - Yes / (R) Rear Fender - Repair Traces - Yes / (R) Rear Door - Repair Traces - Yes / Roof - Repair Traces - Yes / (R) Front Fender, Molding - Scratch - Medium / (R) Front Door, Molding - Scratch - Small / (R) Rear Door, Molding - Repair mark - Difference in Color / (R) Rear Door, Molding - Scratch & Dent - Large / (R) Step, In-panel, Side Spoiler - Scratch - Large / (R) Step, In-panel, Side Spoiler - Repair mark - Difference in Color / (R) Rear Fender, Molding - Scratch - Small / (L) Front Fender, Molding - Scratch - Small / (L) Front Door, Molding - Scratch & Dent - Large / (L) Rear Door, Molding - Repair mark - Difference in Color / (L) Rear Door, Molding - Scratch & Dent - Medium / Overall Exterior - Re-Paint Uneven - Yes / (L) Rear Fender, Molding - Scratch - Minimal / (L) Step, In-panel, Side Spoiler - Repair mark - Difference in Color / Front Bumper, Grille, Lamps - Crack, Gap - Medium / Bonnet, Headlight - Scratch - Medium / Antennae - Damaged - Yes / Trunk Hood, Rear Gate - Repair mark - Difference in Color / Trunk Hood, Rear Gate - Scratch - Medium / Rear Bumper, Lamps, Panels - Scratch & Dent - Large |

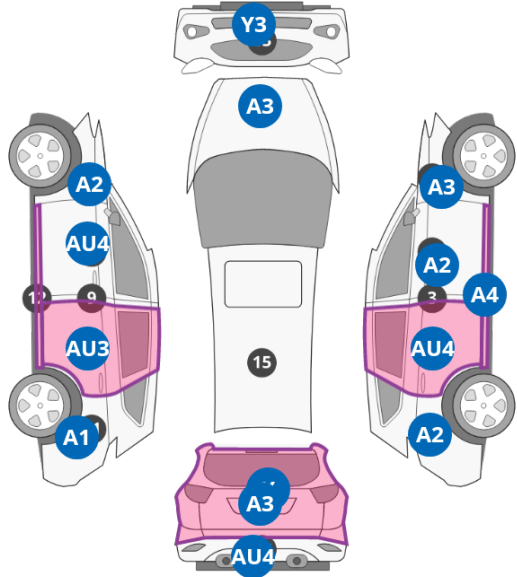
With LTO plate, with warranty booklet, with tools, with jack, no seat cover, with hairline scratches, no spare key, with spare tire, right side mirror not functioning, repaired rear right and left door (difference in color), faded color, some areas are repainted.
