## General Information

| Make | Honda | Model | Civic |
| Registration No. | NAM7145 | Chassis No. | MRHFC6S30JT020285 |

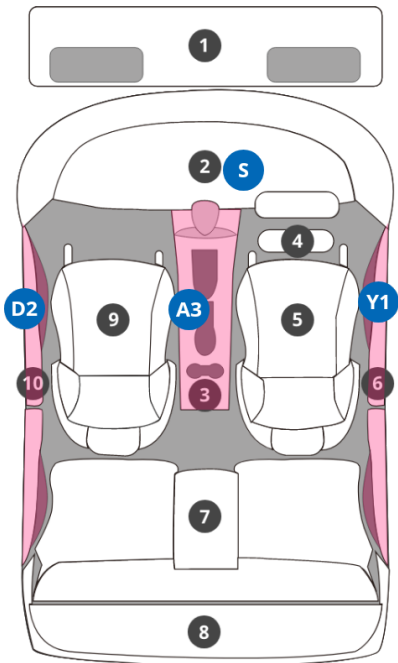
| Interior Evaluation : <b>B</b> | Exterior Evaluation : <b>E</b> |
| <p><b>Remarks</b><br/>Overall Interior - Smell - Yes / (L) Front Trim - Crinkle - Small / (R) Front Trim - Grime - Minimal / Console, Switches, Vents - Worn, Scratch, Cut, Crack - Medium</p> | <p><b>Remarks</b><br/>(R) Front Door - Repair Traces - Yes / (R) Step - Repair Traces - Yes / (R) Front Fender - Repair Traces - Yes / Bonnet - Repair Traces - Yes / (L) Front Fender - Repair Traces - Yes / (L) Front Door - Repair Traces - Yes / (L) Step - Repair Traces - Yes / (L) Rear Door - Repair Traces - Yes / (L) Rear Fender - Repair Traces - Yes / Trunk Hood, Rear Gate - Repair Traces - Yes / (R) Rear Fender - Repair Traces - Yes / (R) Rear Door - Repair Traces - Yes / Roof - Repair Traces - Yes / (L) Step, In-panel, Side Spoiler - Scratch &amp; Dent - Large / (L) Rear Fender, Molding - Scratch &amp; Dent - Small / (L) Rear Door, Molding - Scratch &amp; Dent - Medium / Trunk Hood, Rear Gate - Scratch &amp; Dent - Small / Rear Bumper, Lamps, Panels - Crack, Gap - Large / (R) Rear Fender, Molding - Scratch &amp; Dent - Small / (R) Rear Door, Molding - Scratch &amp; Dent - Small / (R) Mirror - Scratch - Small / (R) Front Fender, Molding - Dent - Large / Front Bumper, Grille, Lamps - Scratch &amp; Dent - Large / Bonnet, Headlight - Scratch - Large / (L) Front Fender, Molding - Dent - Large / (L) Front Door, Molding - Scratch - Small / (R) Front Door, Molding - Scratch - Small / Roof - Dent - Medium</p> |
