## General Information

| Make | Toyota | Model | Hilux |
| Registration No. | NHS1002 | Chassis No. | MR0JB8DD1P3548089 |

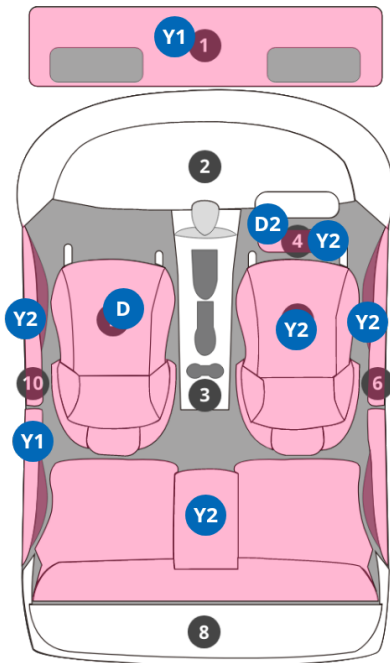
| Interior Evaluation : <b>B</b> | Exterior Evaluation : <b>D</b> |
| <p><b>Remarks</b></p> <p>Rear Seat - Grime - Small / (R) Front Seat - Grime - Small / (L) Front Seat - Worn - Yes / (R) Front Trim - Grime - Small / (R) Front Floor Mat - Grime - Small / (L) Rear Trim - Grime - Minimal / (L) Front Trim - Grime - Small / (L) Front Floor Mat - Worked - Small / Ceiling - Grime - Minimal</p> | <p><b>Remarks</b></p> <p>(L) Rear Corner Panel - Repair Traces - Yes / (L) Side Gate - Repair mark - Yes / (R) Side Gate - Repair mark - Yes / (R) Front Door, Molding - Repair mark - Yes / (R) Front Fender, Molding - Repair mark - Yes / (L) Front Fender, Molding - Scratch - Minimal / (L) Front Door, Molding - Scratch - Small / (L) Rear Door, Molding - Scratch - Small / (L) Side Gate - Scratch - Small / Rear Bumper, Lamps, Panels - Scratch - Small / (R) Side Gate - Scratch &amp; Dent - Small / (R) Rear Door, Molding - Scratch - Medium / (R) Step, In-panel, Side Spoiler - Scratch - Small / (R) Front Door, Molding - Scratch - Small / (R) Front Fender, Molding - Scratch - Minimal / Front Bumper, Grille, Lamps - Scratch - Medium / Bonnet, Headlight - Scratch - Minimal / Cargo Bed Floor - Scratch - Minimal / Roof - Scratch - Minimal / (L) Step, In-panel, Side Spoiler - Scratch - Minimal / (R) Mirror - Scratch - Minimal / Rear Gate - Scratch &amp; Dent - Small / Member (Bolted) - Dent - Yes</p> |
