## General Information

| Make | Toyota | Model | Avanza |
| Registration No. | NJC2494 | Chassis No. | MHFAA1BY7S0040853 |

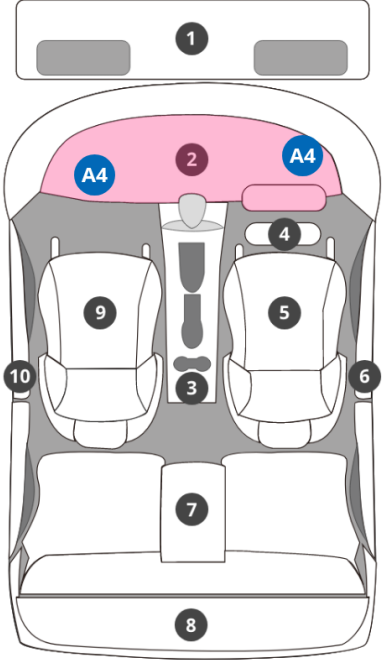
| Interior Evaluation : <b>C</b> | Exterior Evaluation : <b>E</b> |
| <p><b>Remarks</b></p> <p>Steering Wheel - Worn, Peel, Crack - Large / Dashboard - Worn, Scratch, Cut, Crack - Large</p> | <p><b>Remarks</b></p> <p>(R) Front Door - Repair Traces - Yes / (R) Step - Repair Traces - Yes / (R) Front Fender - Repair Traces - Yes / Bonnet - Repair Traces - Yes / (L) Front Fender - Repair Traces - Yes / (L) Front Door - Repair Traces - Yes / (L) Step - Repair Traces - Yes / (L) Rear Door - Repair Traces - Yes / (R) Rear Door - Repair Traces - Yes / (R) Rear Door, Molding - Scratch &amp; Dent - Large / (R) Step, In-panel, Side Spoiler - Scratch &amp; Dent - Medium / Front Bumper, Grille, Lamps - Scratch - Medium / Roof - Dent - Medium / (L) Rear Fender, Molding - Dent - Medium / Rear Bumper, Lamps, Panels - Scratch - Large / (R) Rear Fender, Molding - Scratch - Small / (L) Rear Door, Molding - Scratch - Small / (L) Front Door, Molding - Scratch - Small / Front Bumper, Grille, Lamps - Repair mark - Difference in Color / Rear Bumper, Lamps, Panels - Repair mark - Difference in Color</p> |
